**Report No.** 43-02

**Address of property inspected:** Artane, Dublin 5.

**Date of Inspection:** 4th April, 2011

This report has been prepared to ascertain the source and provide possible remedies for the presence of moisture stains on the party wall between our clients rear extension, and a similar rear extension to the adjoining property to the south-west.

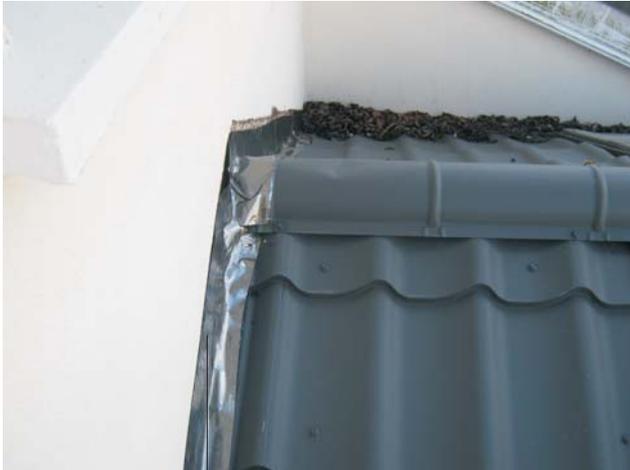
It was noted that a number of flashings were missing in completing the roof, and that a type of heavy duty adhesive tape had been used to substitute these. This tape was peeling off in places.

Adhesive tape flashing peeling off wall

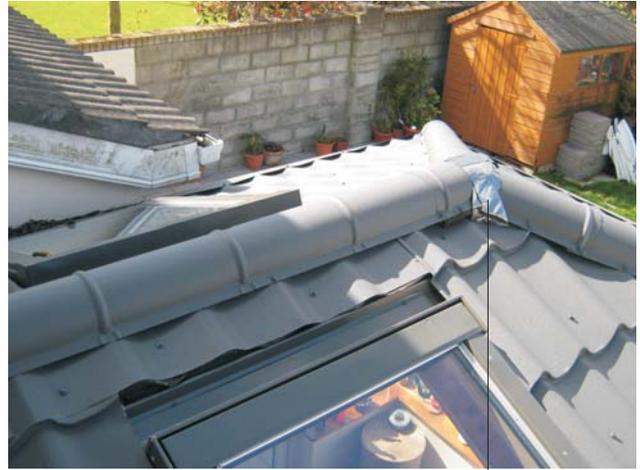
Adhesive tape flashing peeling from capping junction

The incorrect fitting of adhesive flashing tape in the above locations would lead to a very temporary solution to fitting permanent flashings chased in to walls, and proprietary capping/closing sections to the ridge tiling.

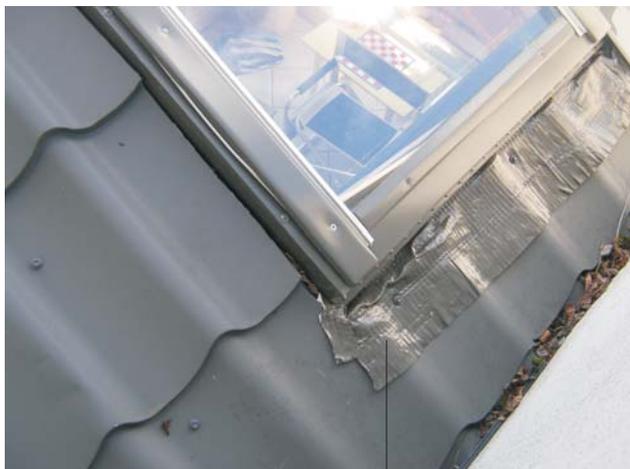
Badly fitted/ damaged Velux flexible flashing

The nature of the construction would suggest that the re-roofing of the extension was constructed in a hurried nature, and that final flashings were not fitted.

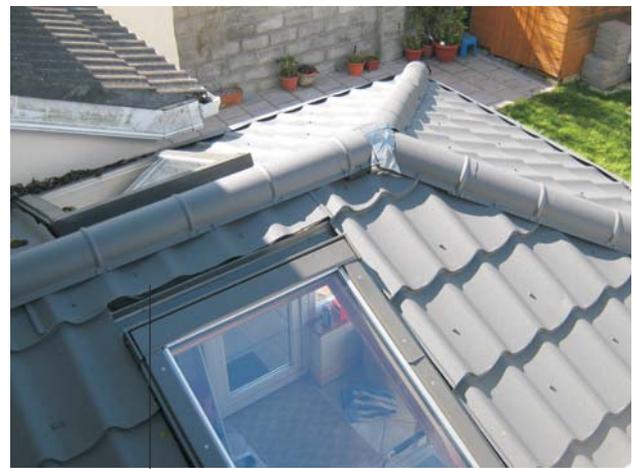
The roof material, a lightweight profiled metal sheeting had been roughly cut in places and possible proprietary closing/flushing pieces may be absent to securely seal the exposed end sections of the metal sheeting.

Exposed end section to profiled sheeting

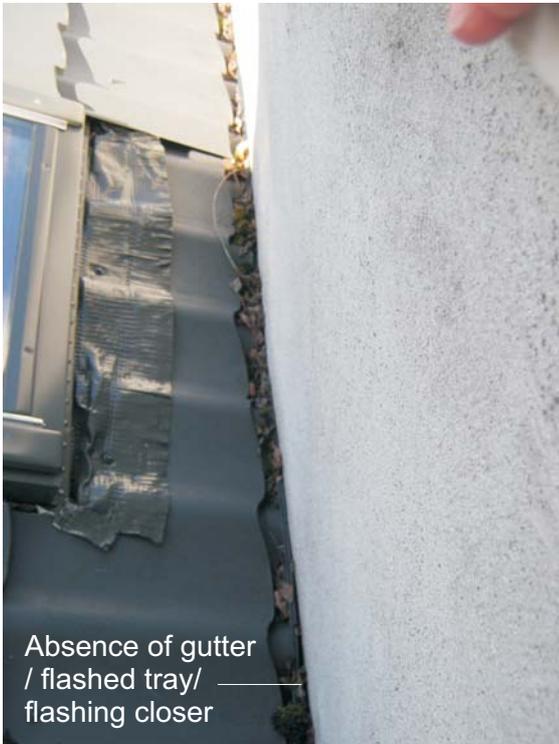
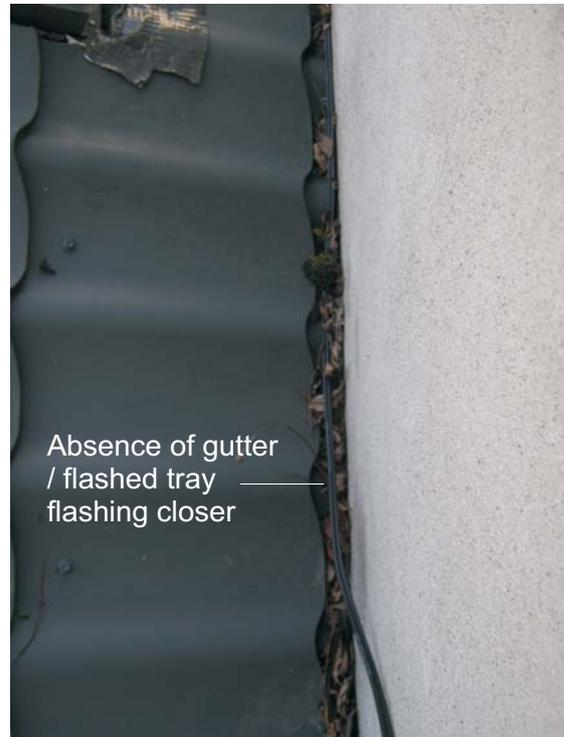
**Photo looking directly down on roof**

On inspection of the junction of the roof, and the parapet wall, it appears that there is no valley gutter installed to allow water to run off the roof correctly.

In the event of any reasonable rain shower, water will run directly on to the parapet wall. The nature of the roofing material, which has a relatively smooth surface, allows water to move at a much faster rate across it, unlike materials such as slate or concrete roof tiles, thus compounding the problem.

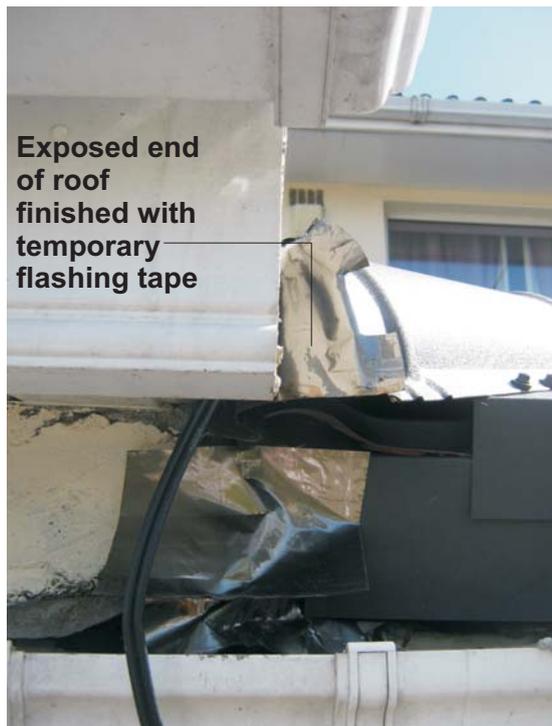
**Photo looking at roof edge/parapet**

A prolonged spell of rain or the presence of excessive snow, would allow water to be absorbed into the wall allowing damp to spread through it.

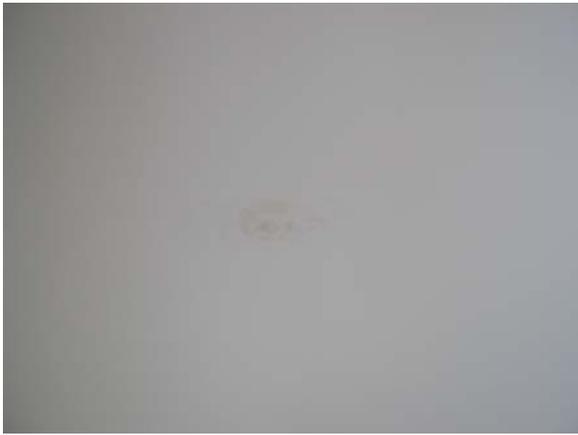
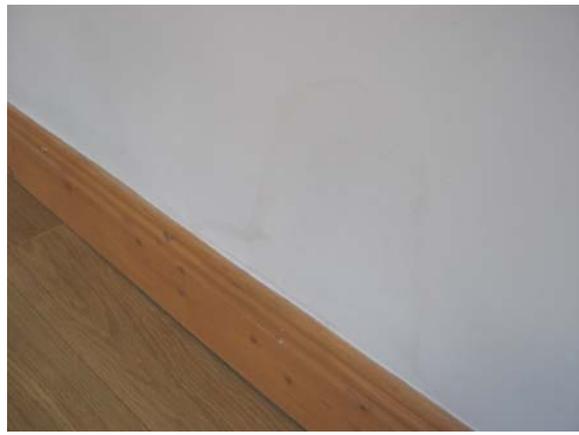
**STAINING ON PARTY WALL**

The incorrect valley detail has allowed water to flow onto and down the boundary wall of our clients property resulting in staining of the plasterwork in his kitchen.

No invasive investigation has yet been conducted into the drylined party wall, and this may prove that the water ingress is much worse than what is appearing on the surface.

Our client also wants an investigation of the previously mentioned drylined party wall to be conducted, and any damage to the wall as a result of the leaking roof to be repaired, repainted and made good to its original condition.
