Report No. 43-02

This report has been prepared to ascertain the current condition of the existing roof to the building, and recommendations for possible replacement, and/or repair of same.

The building in question is a three storey apartment block constructed in the late 1960's / early 1970's. The roof is of flat roof construction.

Report No. 43-02 - ADDENDUM

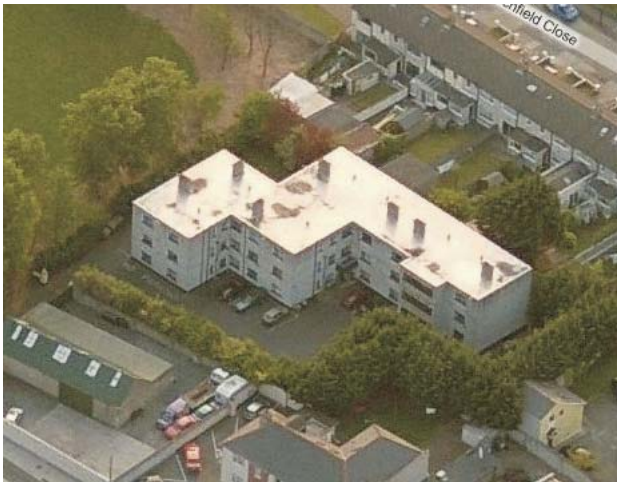
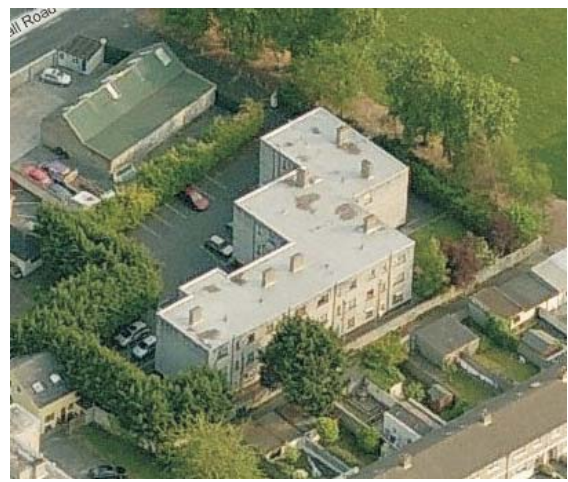
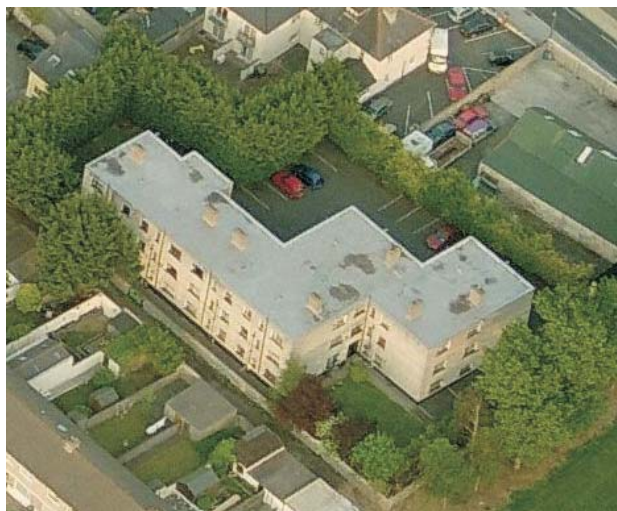
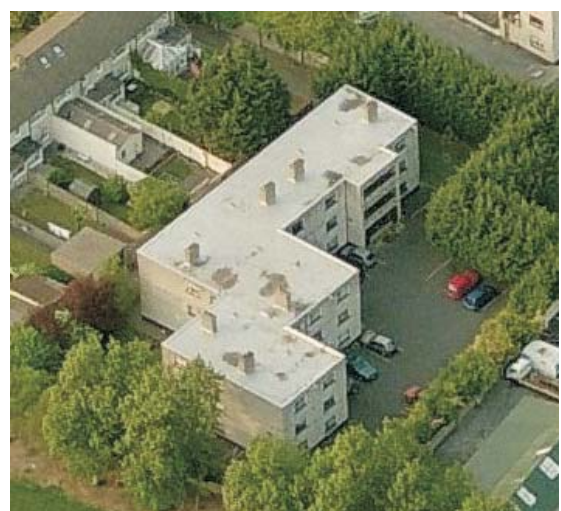
From the elevational photographs on the previous page, and the vertical photograph below, it is evident that ponding is occurring on the roof at various locations.

While this is not necessarily a bad thing during parts of the year when the air temperature is above freezing point, the last two winters with extended cold periods meant prolonged spells of time where this ponding was frozen.

Prolonged frozen spells may lead to cracking in the felt, and subsequently to leaks occurring.

As part of the renovation works we would also propose removing all areas of ponding on the roof, and ensuring all drain points are functioning properly.

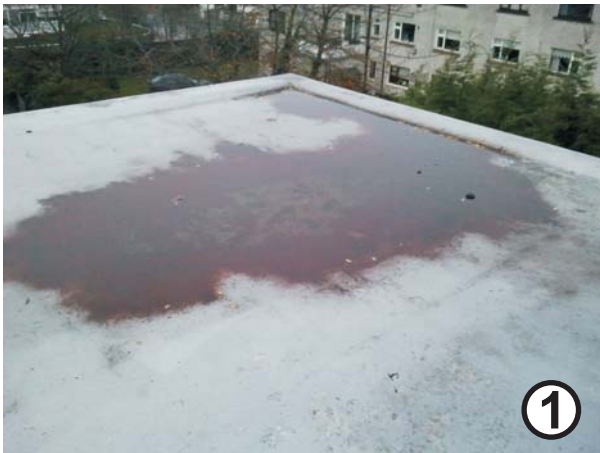
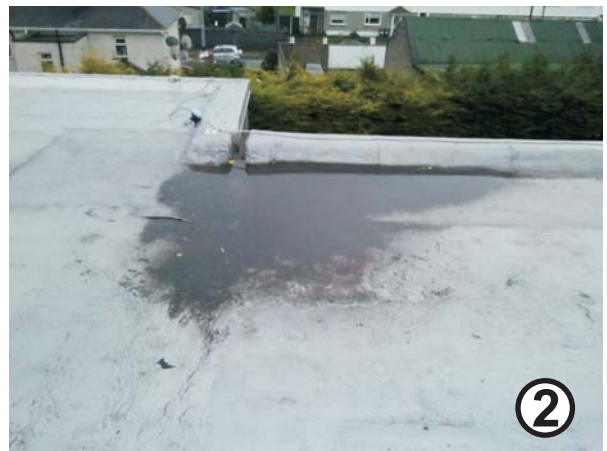
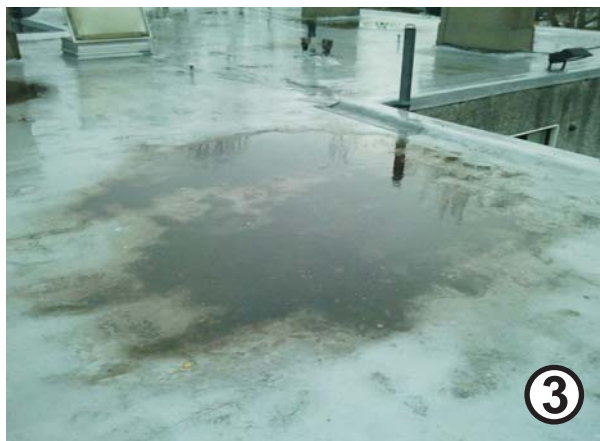
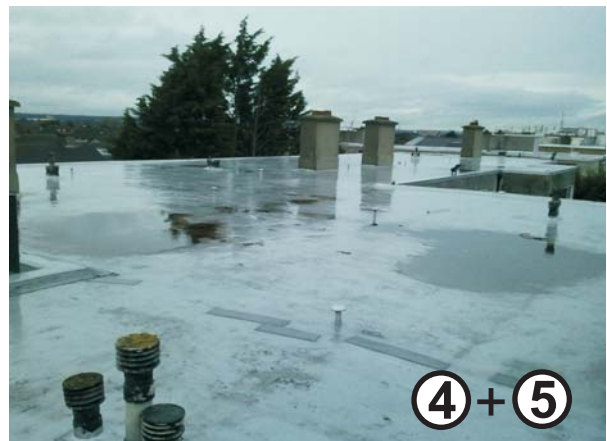
Cracking is also evident at various locations on the roof, and around the parapet wall detailing, with some repairs evident. Conditions on the day of inspection were dull and wet.

The wet surface may have partially obscured other cracks, therefore the locations indicated below are not exhaustive.

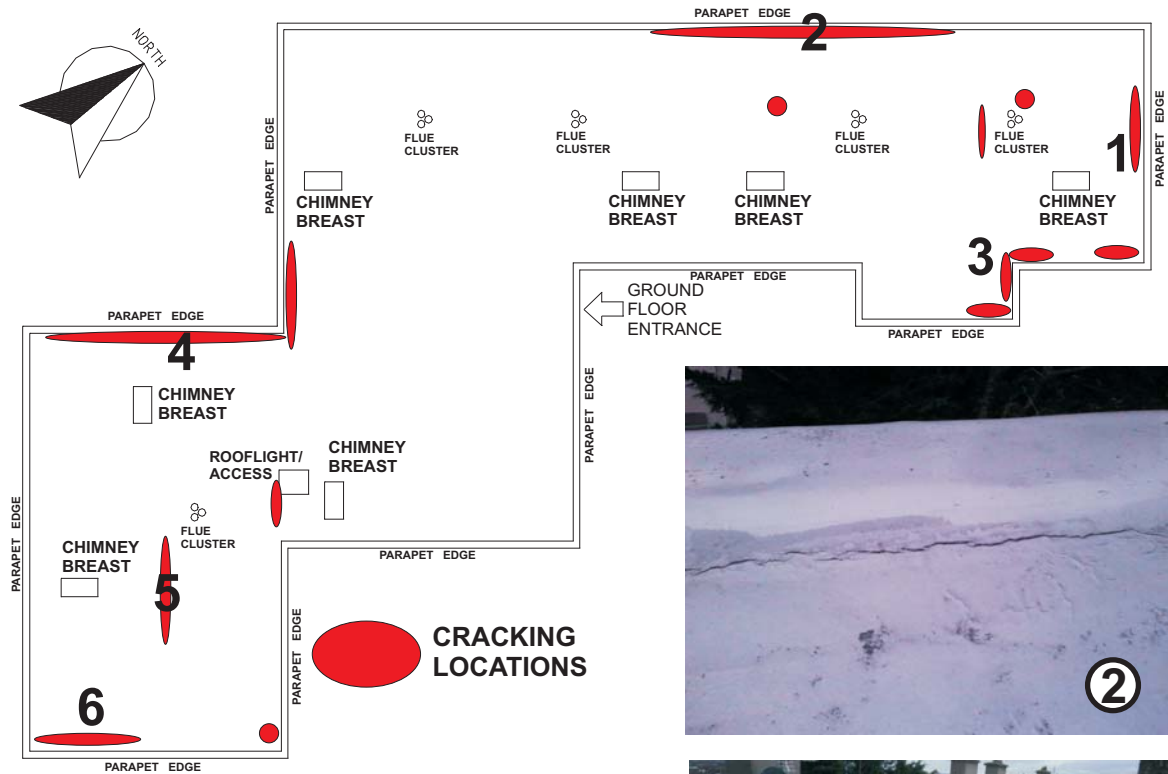
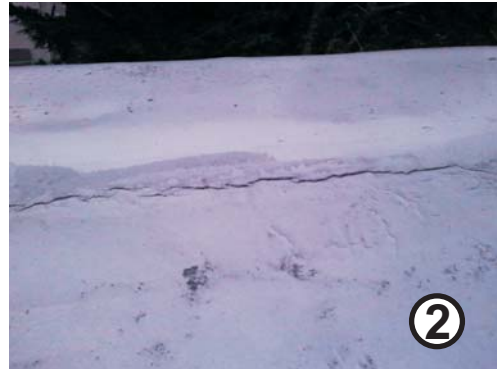
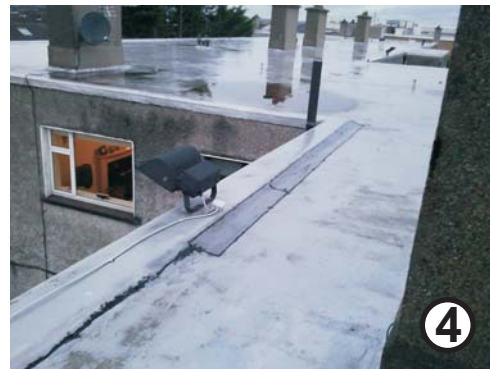
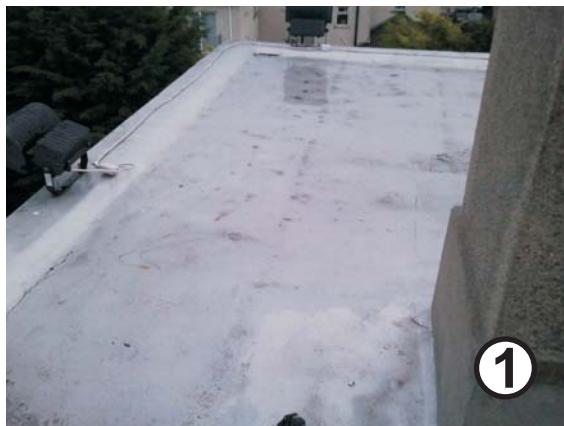
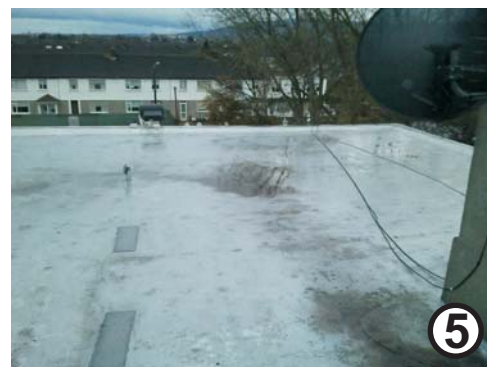
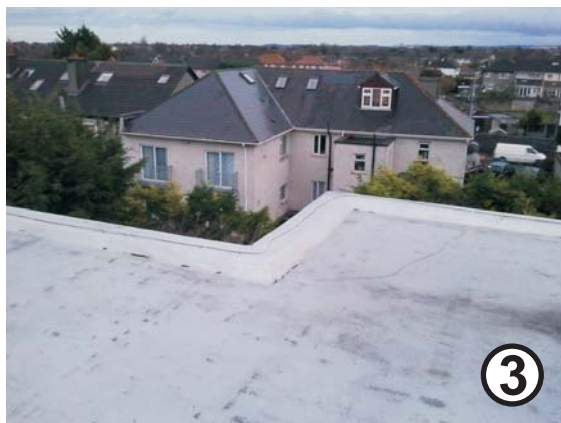
It is our opinion that the roof finish may be ending its useful life, as the amount of cracking visible suggests.

We would therefore recommend that the roof be replaced in its entirety with a similar equivalent. This would typically be 2no.layers of torch on felt dressed up around all chimneys, fixtures and fittings and suitably flashed. Application of a layer of reflective paint too will extend the life of the roof material.

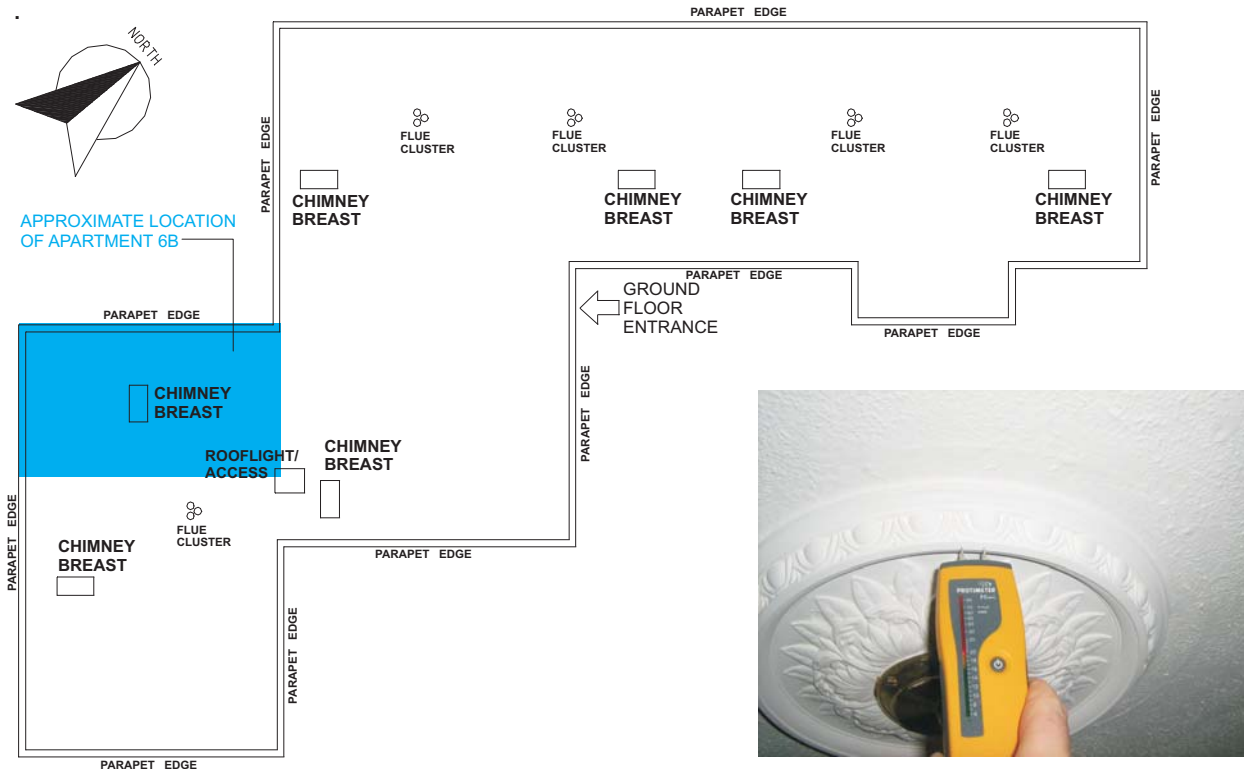
We revisited the apartment scheme to investigate reported damp issues in Apartment 6b, and confirm that moisture metre readings at the head of the window in the kitchen and the ceiling rose/light fitting in the kitchen showed a raised level of moisture in that area, with 18% being read in the kitchen, and 20% at the rose in the living room

Moisture meter reading of 20% at ceiling rose

This is a good indication that moisture is leaking through the roof and appearing along the paths of least resistance at window heads and light fixtures in the apartment.
