**Report No.** 43-03

**Address of property inspected:** xxxxxxxxxxxxxxxxxxxxxxxxxxxx

This report has been prepared to ascertain the reasons for excessive heating bills for the property, and also the damage to the ceilings to bathrooms on the first floor of the dwelling.

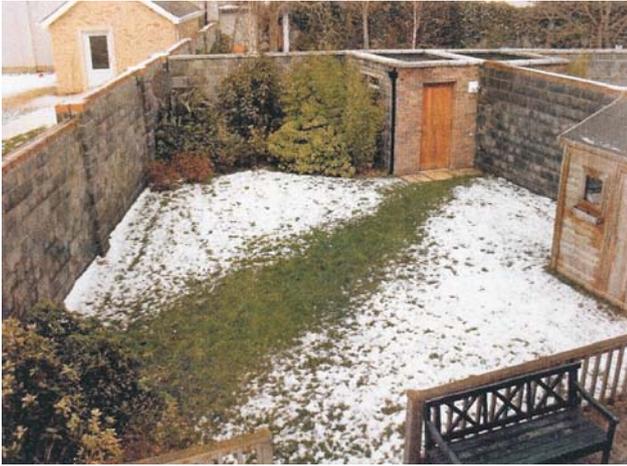
Line of heating pipe visible via melted snow

**We feel that the specification of piping provided as evidenced at the trial hole is completely inadequate. This inadequate level of insulated piping has led to the quick thawing of snow as per our previous photograph, which in turn indicates an excessive level of heat escape into the ground surrounding the pipe run.**

**We recommend that all flow and return pipes from the boiler house to the dwelling be replaced by a suitable, properly & well specified piping which is fit for purpose.**

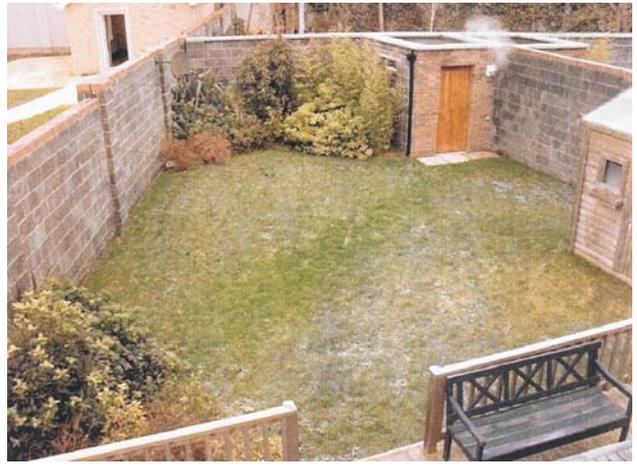
Line of heating pipe visible via melted snow

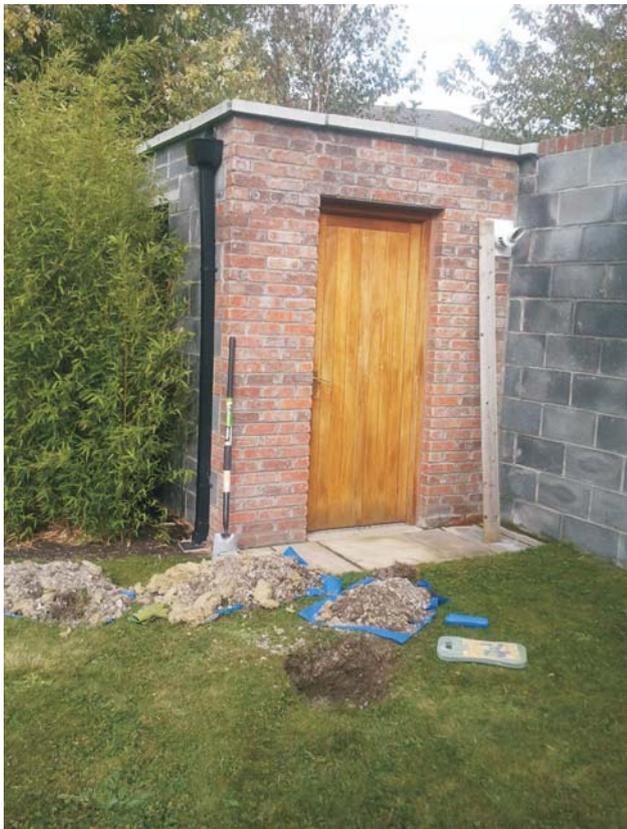
Hole dug adjacent to boiler house

2 x 100mm flexible ducting

Hole previously broken in pipe by contractor

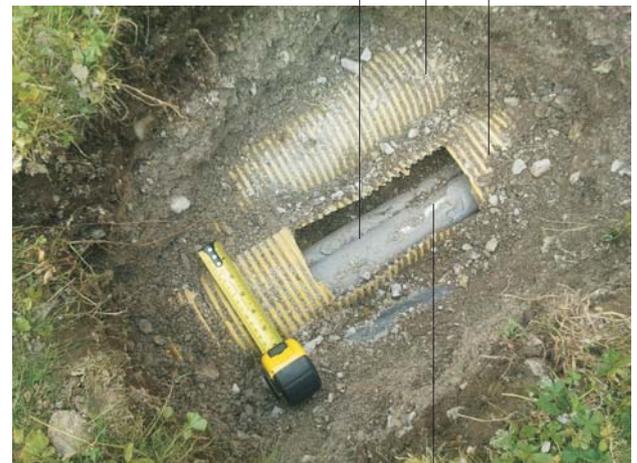
Flow and return pipes encased in grey sleeve insulation (12mm approx.)

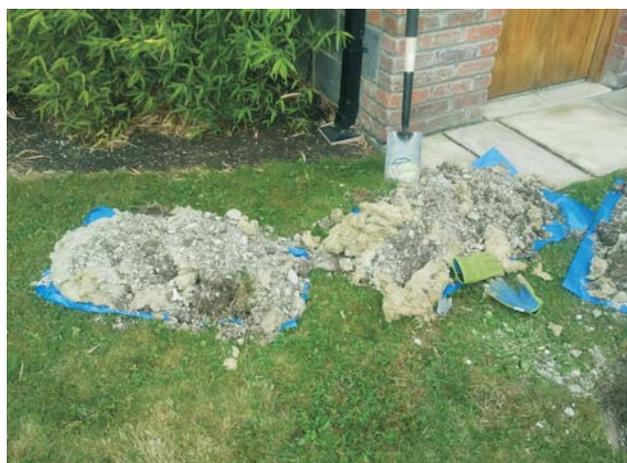
Attic insulation previously placed above 100mm piping dug up as part of trial hole

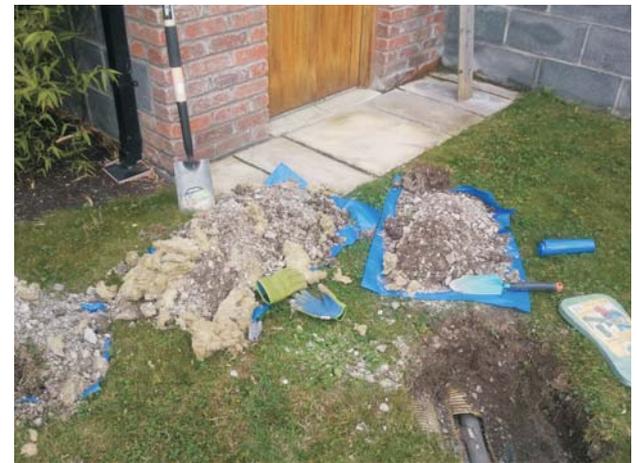
Attic insulation previously placed above 100mm piping dug up as part of trial hole

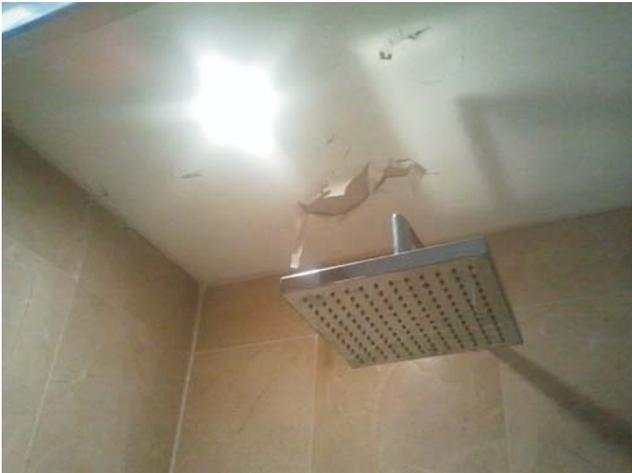
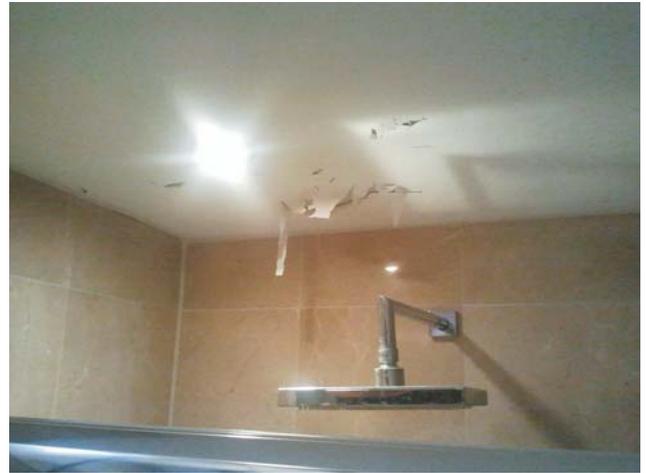
**BATHROOM CEILING**

The second issue in relation to the dwelling relates to the peeling of paint from the ceilings in both the first floor bathroom, and the en suite off the master bedroom which too is on the first floor. Both the bathroom, and ensuite are located beside each other.

While both the bathroom and en suite are serviced by the mechanical ventilation system, it was noted that a moisture content of approximately 20% was metered on the ceiling in the vicinity of the shower area.

This would suggest that the mechanical ventilation system cannot adequately cope with the volume of moist air which is being retained in both bathrooms, and that this has led to the excessive moisture penetration into the ceiling above the respective shower areas, leading to paint peeling from these ceilings.

**We recommend that a new mechanical rapid extract system be installed in both bathrooms adjacent to the respective shower areas to speedily remove moist air therefore reducing the moisture retention in the ceiling.**

**We feel that there must be some cold-bridging contributing to this issue, and therefore are recommending that the ceiling be thoroughly insulated with a rigid board insulation above the bathrooms and the attic space be properly draught sealed.**

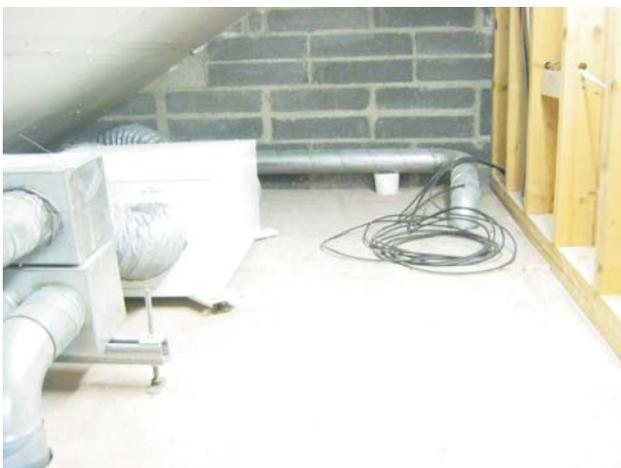
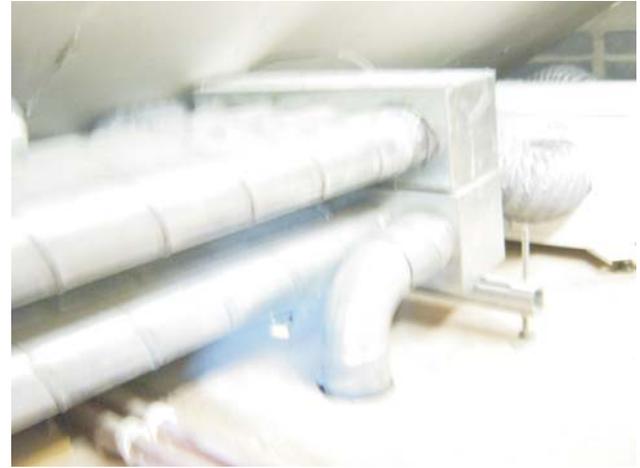
**DORMER ATTIC SPACE  
ABOVE BATHROOMS**

We also noted that on the day of our inspection the attic space above the bathrooms containing the heat recovery unit was considerably colder than the room adjacent to it. While our survey was not invasive, we have to assume that the attic space has been thermally insulated, but due to a strong draught being present at the time of inspection, it obviously has not been draught sealed.

**We also feel that based on this inspection, all other attic areas should be suitably thermally insulated and draught sealed.**
