**Report No.** 42-07

**Address of property inspected:** xxxxxxxxxxxxxxxxxxxxxxxxxxxxxxxxxxxx

**Date of Inspection:** 1st February, 2013.

This report has been prepared to ascertain the source of damp patches occurring in the bedrooms and living rooms of nos. xxxxxxxxxxxxxxxxxxxx, and the presence of structural damage in bedroom 2 of xxxxxxxxxxxxxxxxxxxx

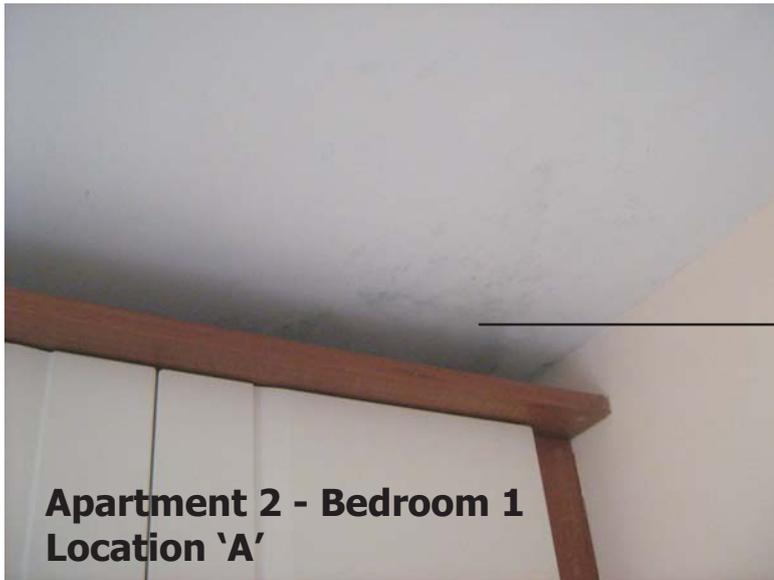
Mould spores clearly visible above fitted wardrobes

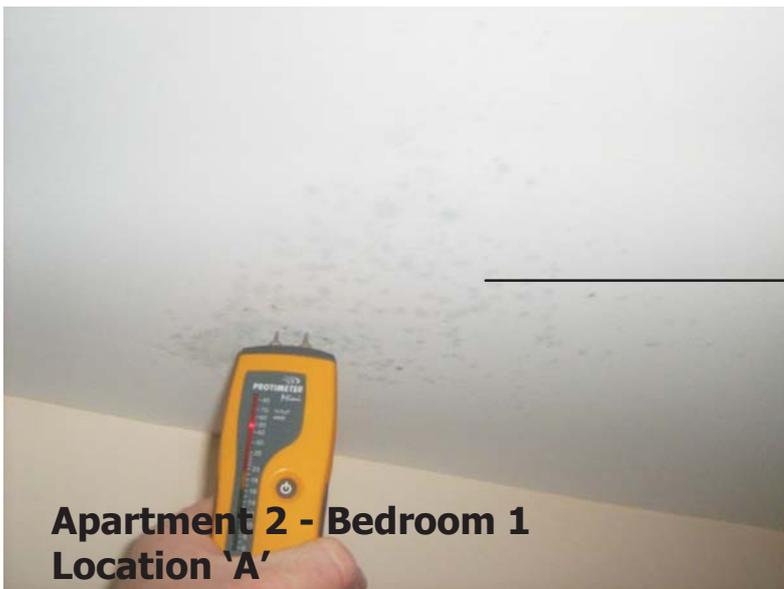
Moisture meter reading 50% moisture at location 'A'

Remove a minimum of two rows of concrete tiles from balcony adjacent to rear walls of both first floor apartments.

Remove all flashings and bellcasts at rear walls of both first floor apartments including flashings at door thresholds.

Employ a competent, experienced flat roof roofing contractor to dress up a new roof finish from existing roof to a minimum 150mm above finished (concrete tile) floor level including correct dressing/mitreing to corners.

Re-fit new flashings to appropriate height (minimum 150mm above finished (concrete tile) over.

Re-render wall to include new bellcast to flashing detail and make good.

On completion water test the new roof/flashing to establish remedy is working correctly.

Repair all damaged ceilings, re-skim, re-paint and make good.

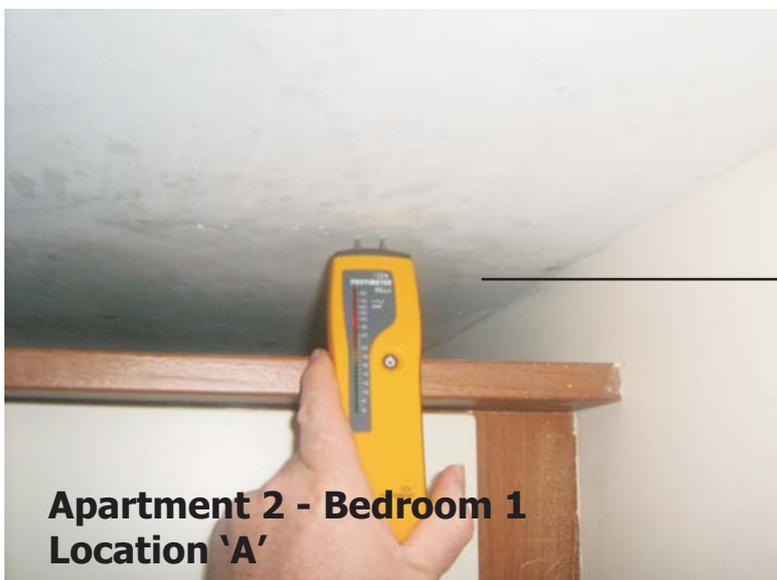
Moisture meter reading 50% moisture at location 'A'

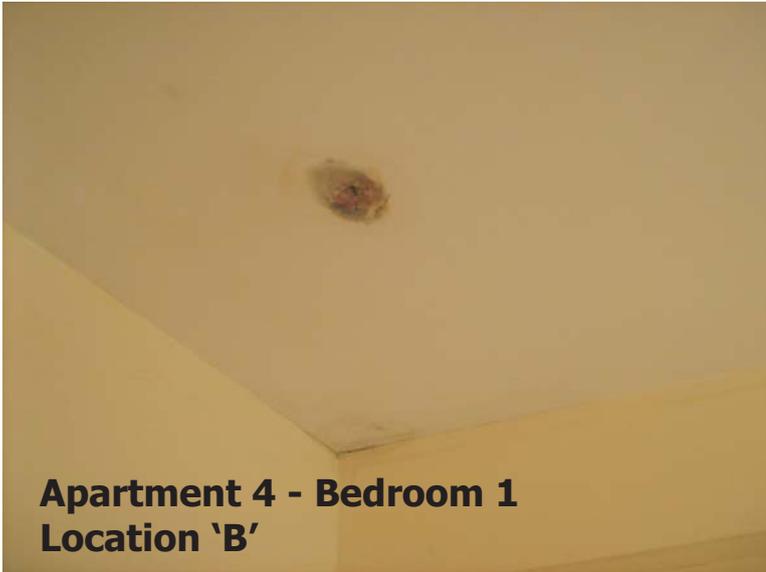
Hole in ceiling from damp penetration

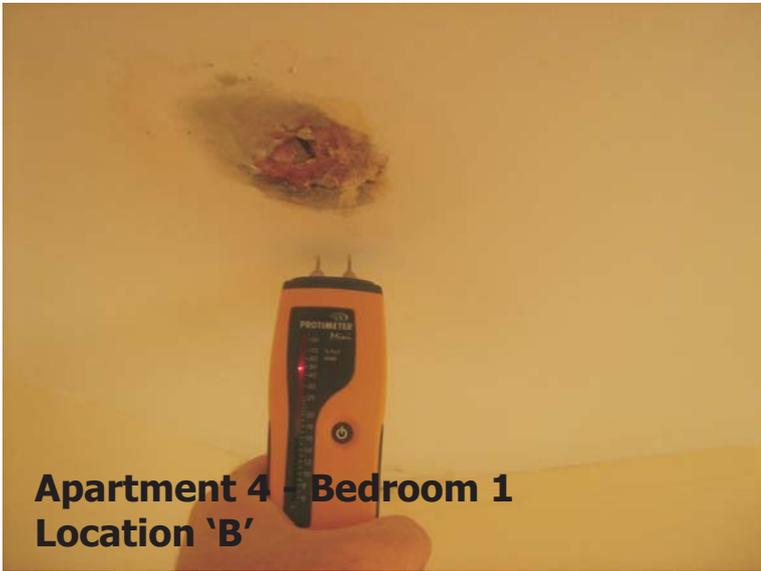
Moisture meter reading 50% moisture at location 'B'

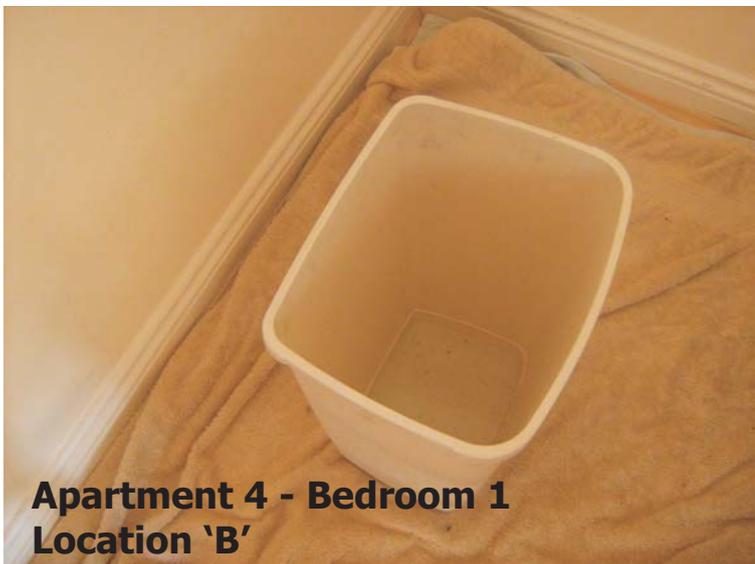
Water visible in bucket on floor below location 'B'

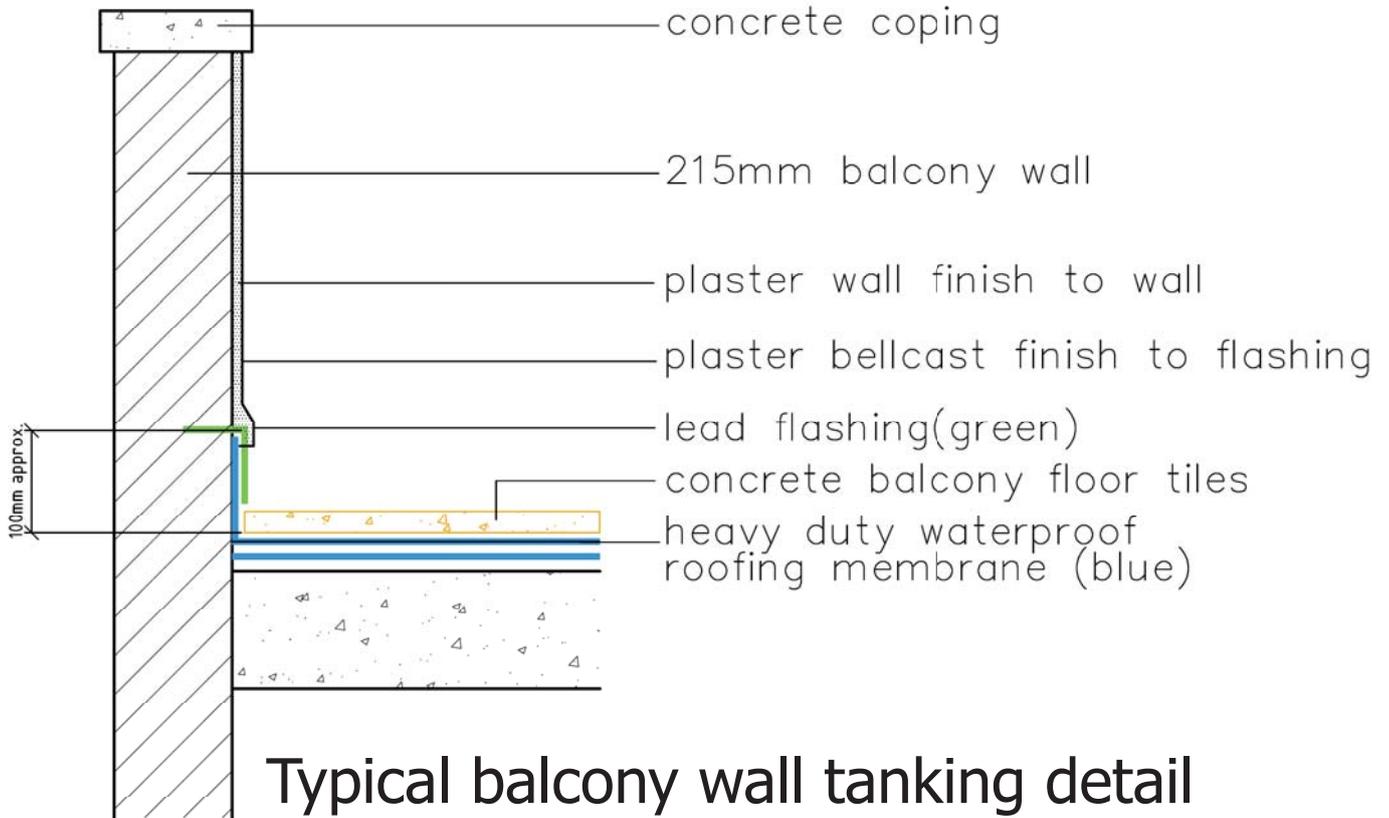
The waterproof membrane appears to have been extended up the walls, and subsequently flashed down onto, with a plaster bellcast dressed down to complete the flashing detail similar to the detail indicated below.

We would have concerns relating to the positioning of the flashing detail relevant to the finished floor level of the balcony, as it appears very close to the ground.

In the event of a prolonged spell of rain, and in combination with the previously mentioned factors (no fall to roof/clogged drains) could lead to excessive water being retained on the balcony and allowing it to climb up and over the flashing detail by capillary action thereby breaching the roofing membrane and allowing it into the walls and ceilings adjacent to the balconies.

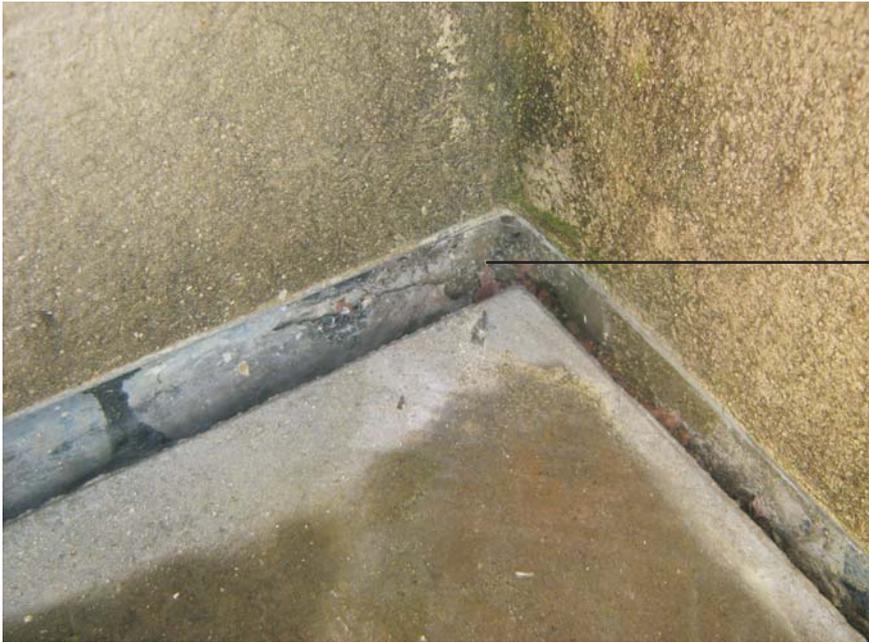
On closer examination of the flashing details, we noted significant damage to the flashings at the corner of the balcony wall with the rear external wall at apartment 1 (location G on diagram page 2.).

Flashing completely disintegrated at location G.

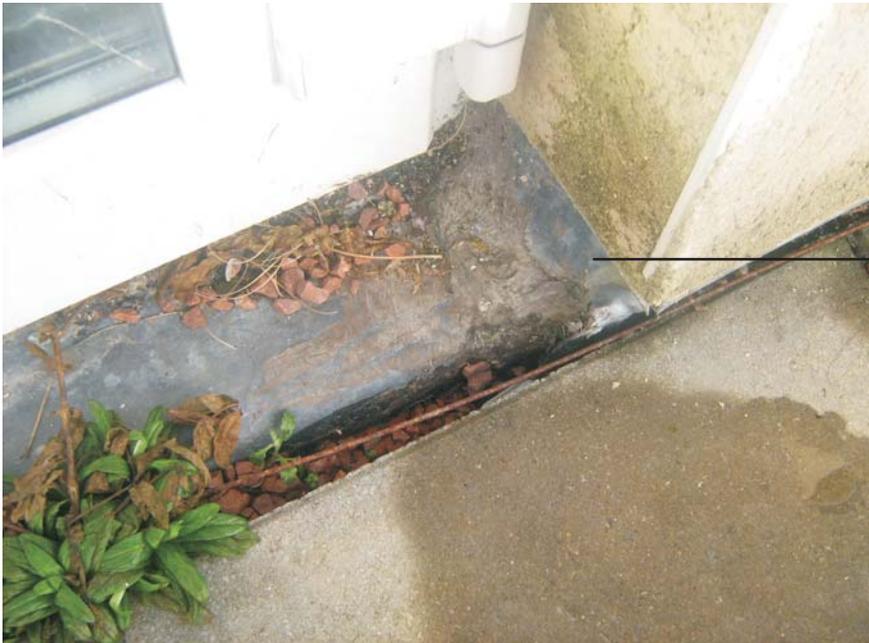
Flashing pinched at door jamb at location H.

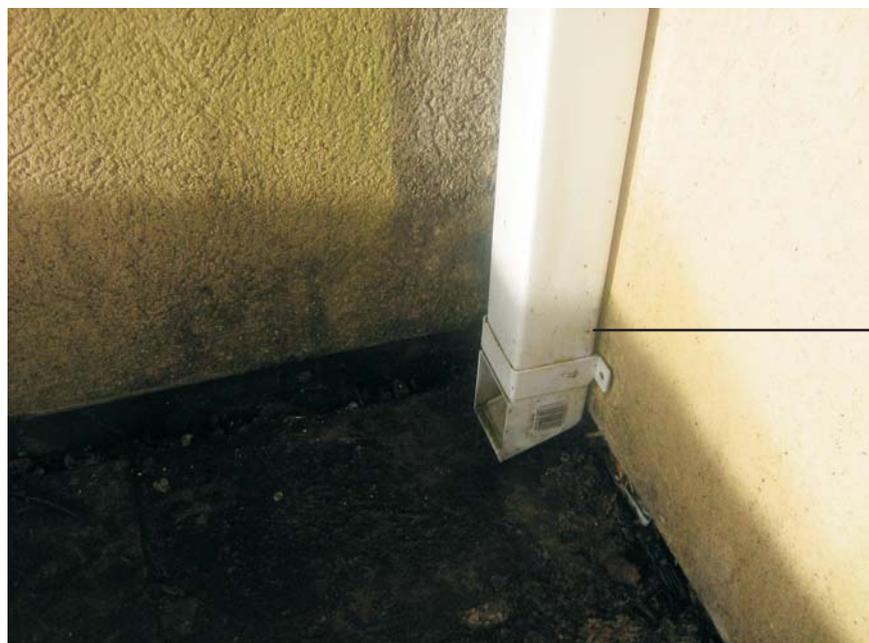
Rainwater pipe (indicated on dwg-page 2) discharging water onto balcony from adjacent roof and ponding at location.

We also note a rainwater pipe discharging directly on to the balcony, and this water has been ponding at this location.

This combined with the rainwater pipe discharging water which subsequently ponds on to the balcony of apartment 1 can only compound any problems at these locations.

Extend rainwater pipe discharging directly on to balcony to drain point or alternative location ensuring water finally discharges to a proprietary hopper head/rain water pipe and eventually discharges to a gully trap installed as part of the surface water drainage on site.

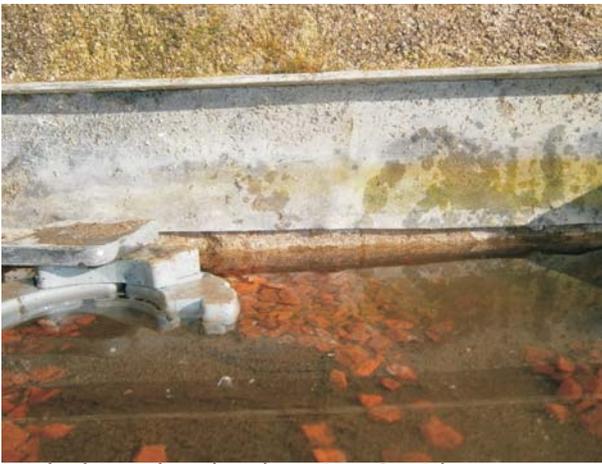
Flashing detail at location G with concrete paving removed

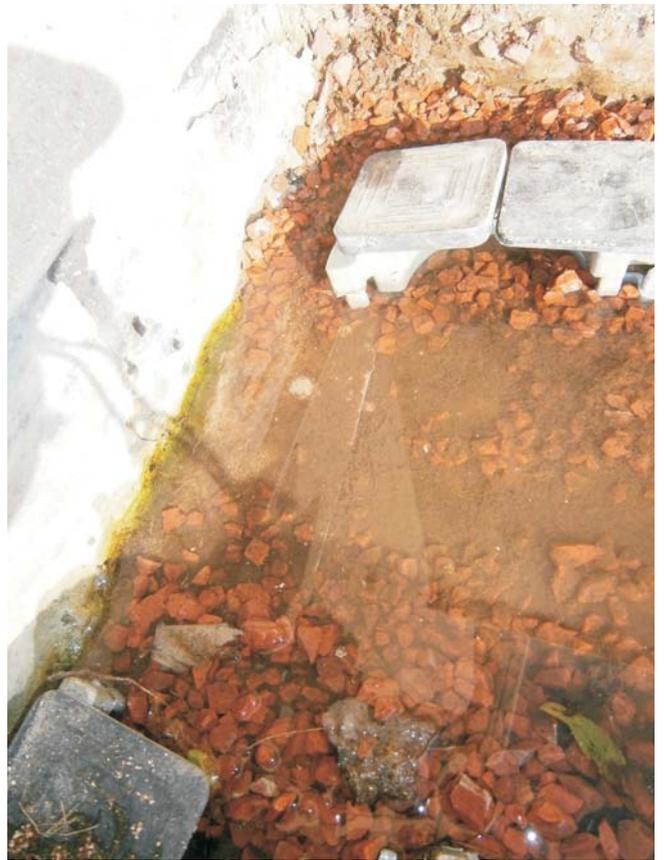
Flashing detail at location G with concrete paving removed

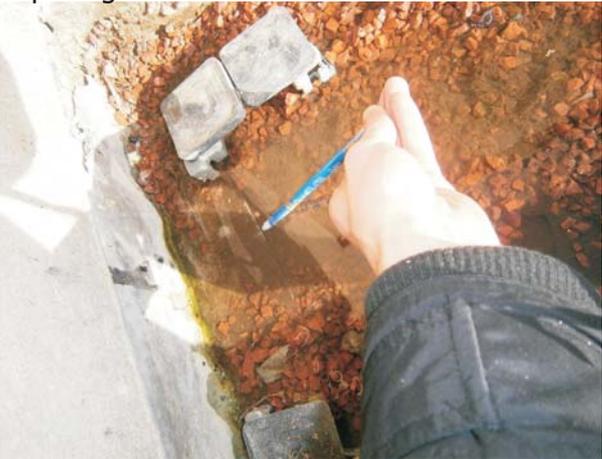
Flashing detail at location G with concrete paving removed

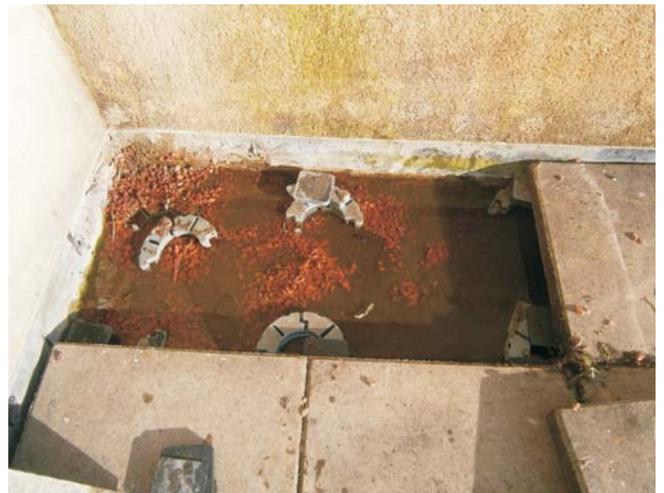
Flashing detail at location G with concrete paving removed

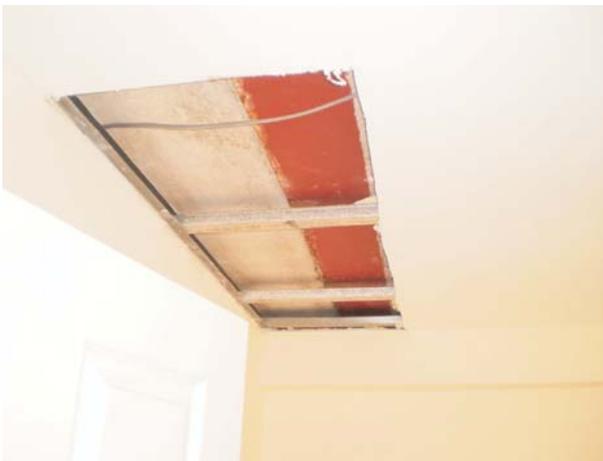
Portion of ceiling removed to show water damage along steel beam

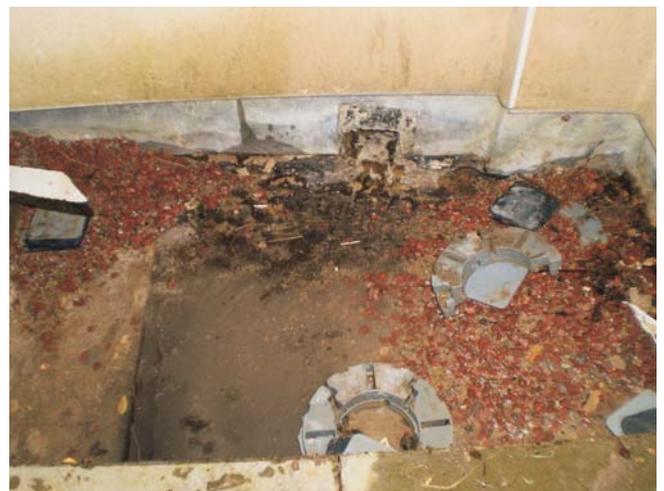
We noted that the perimeters of the balconies were filled with fine draining stone, but no suitable grills had been placed at the drain points, effectively clogging these, and as a result this would slow down the escape of water from the balconies.

Location of balcony drain with concrete paving removed - wall structure inhibiting flow of water to hopperhead

Remove all draining stone choking balcony drains, and install perforated covers to same ensuring drains remain free running. Examine if existing structure is inhibiting flow of water from roof. Cut back structure if required, and re-flash/re-seal as appropriate, water proof and make good.

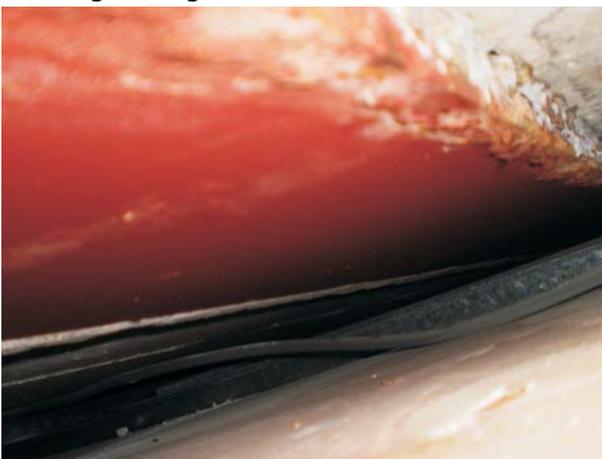
Portion of ceiling removed to show water damage along steel beam

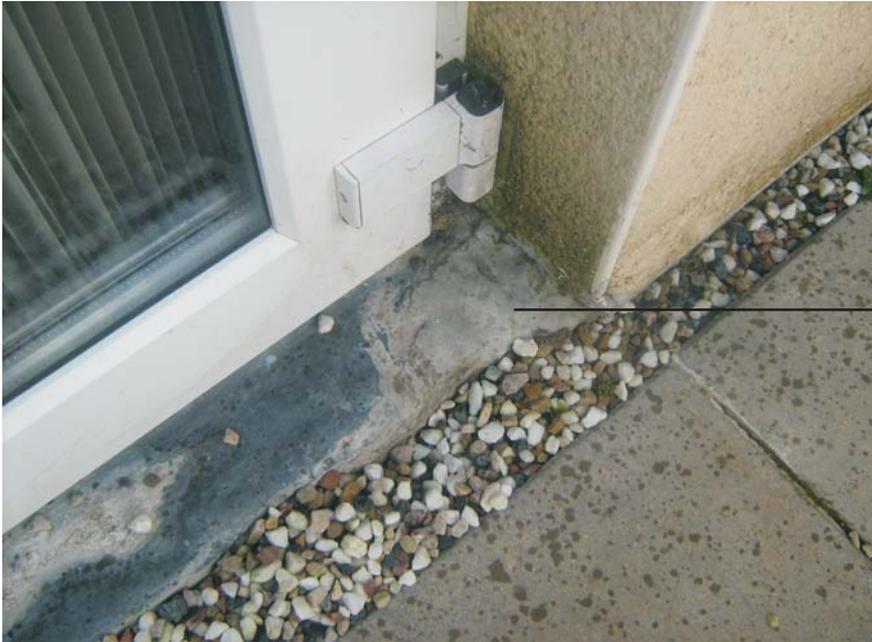
On examining the balcony to apartment 38 we notice similar damage (and repair) to the flashing adjacent to the apartment wall and the jambs of the balcony doorset at locations J & K respectively.

Flashing damaged and repaired with flexible sealant at location J.

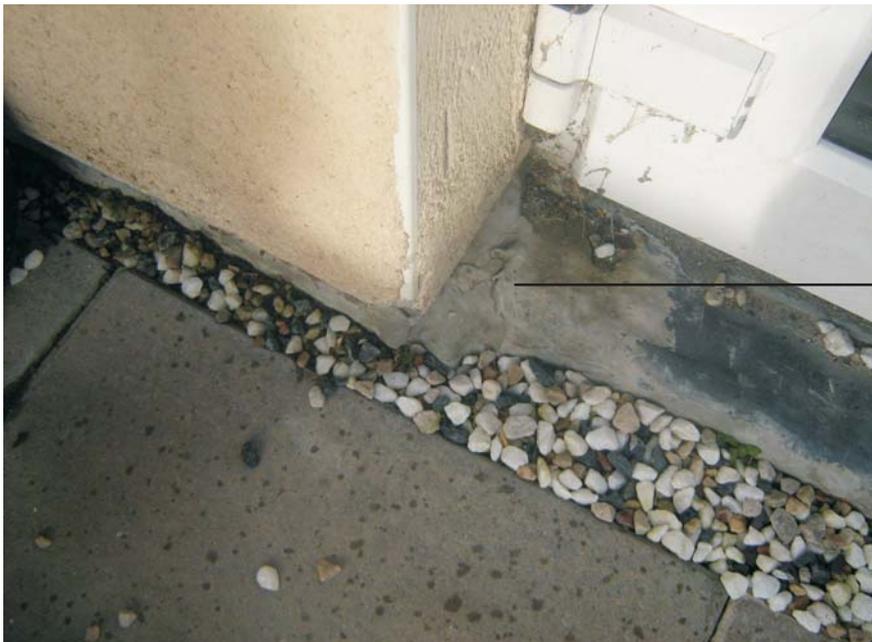
Flashing damaged and repaired with flexible sealant at location K.

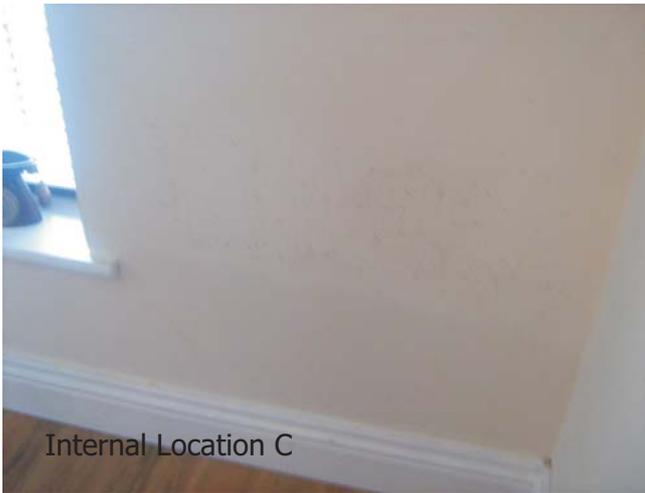
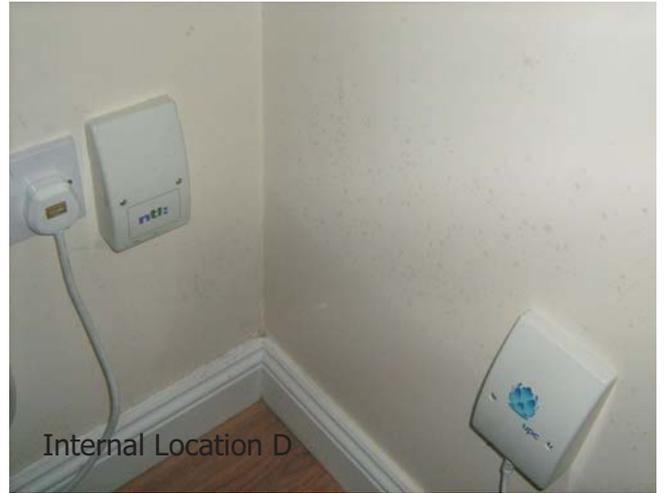
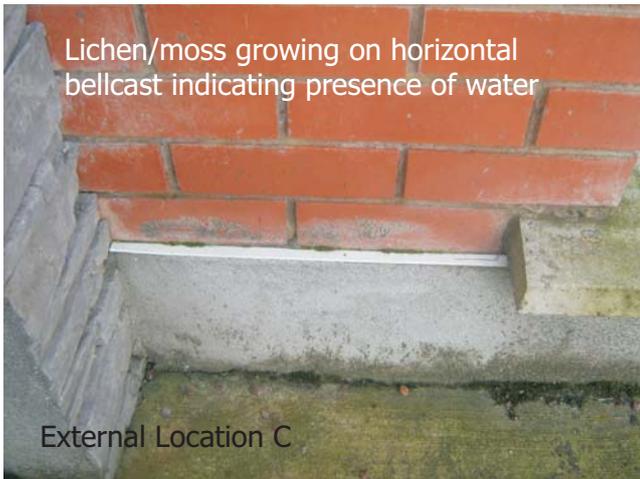
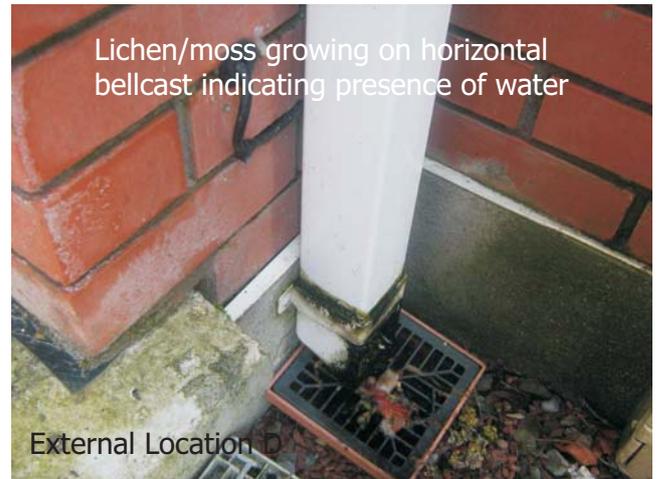
We also note mould spores at various locations C,D,E,F and G on the ground floor of both apartments
