BELL
ASSOCIATES
ARCHITECTURE
PLANNING

Report No.41-10

Address of property inspected: Balbriggan, Co. Dublin.

Date of Inspection: 24th November, 2009.

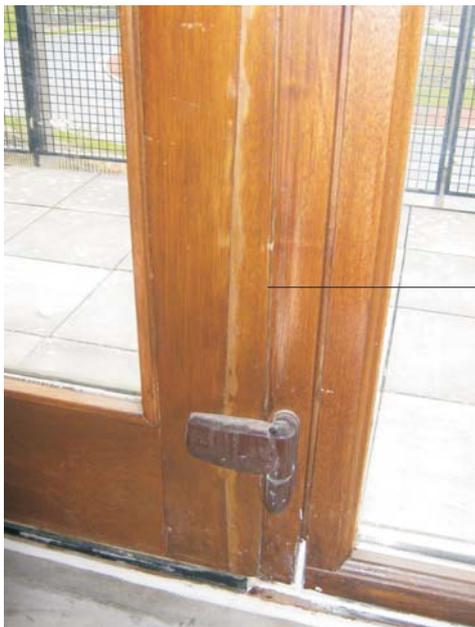
On the day of inspection, it was noted that there was an excessive whistling noise was evident from the doorset, and that when pressure was applied to the right hand door, this noise ceased. The right hand door has been damaged and a large crack extends from the bottom hinge upwards to the middle right hand side of the door, as though the hinges had been forced, damaging the door.

Crack to RHS
of doorset

Replace damaged RHS door to doorset, re-fit new door, and adjust so that closing mechanism grabs and seals correctly thereby sealing draught/whistling noise.

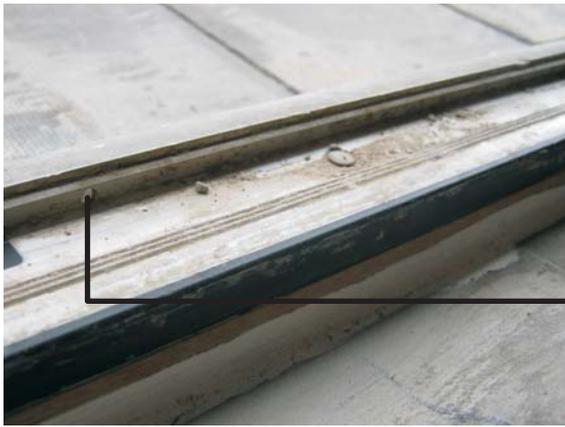
On inspection, the cill/threshold arrangement appears to allow wind driven rain to be forced up under the closed doorset, and in on to the floor.

Water driven up under door cill

Examine cill/threshold, and replace/repair as necessary preventing wind driven rain being forced up under doorset while maintaining correct water run off from glazing doorset.

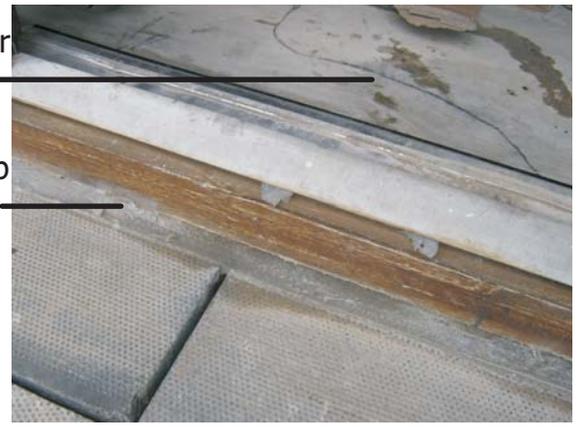
Water driven through weep holes

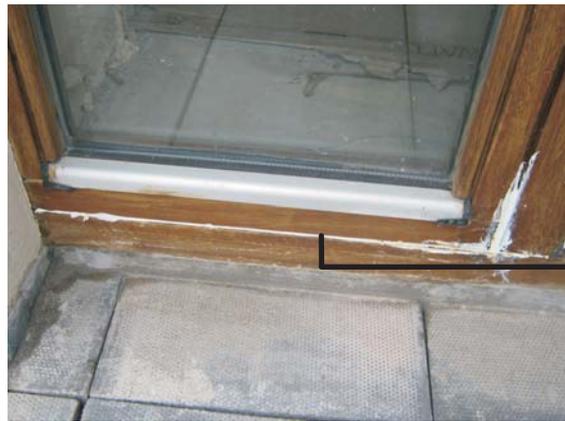
This sealant appears to have been applied in a varied manner, and holes are evident in it, obviously allowing water to ingress beyond the external face of the building.

Missing mortar at window head

Remove all sealant applied to jambs and head of doorset and windows, re-apply new sealant and make good.

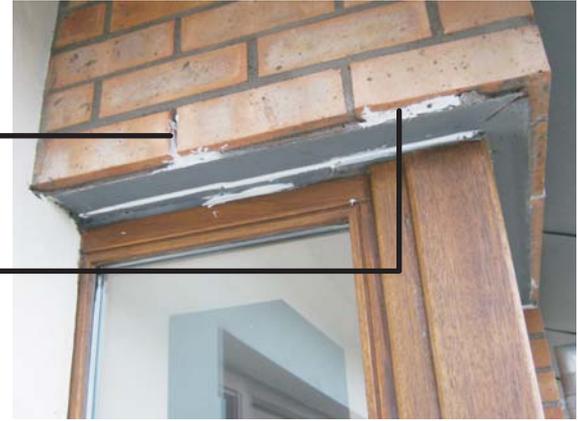
Temporary emergency repairs by client

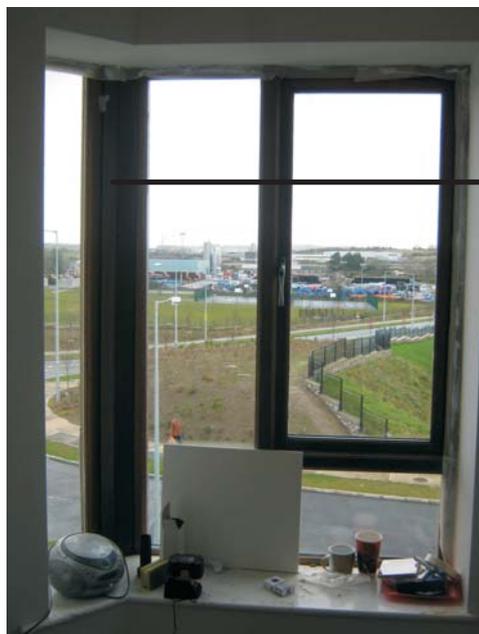
Cosmetically, the rebated closer piece covering the support does not match the hardwood timber in the window frames

Mismatched
closer piece

Replace closer piece with matching closer and make good.

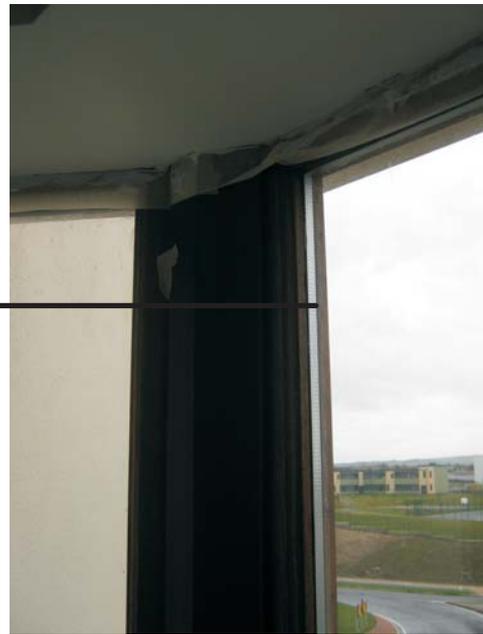
The glazing panels fixed in to the windows with hardwood beading appear to have an excessive amount of silicone sealant between the beading and the glazing panel.

Excessive sealant
to glazing section

Remove all glazing sections, and correctly re-fit with appropriate tape.

Fit beading ensuring adequate pressure is being applied to glazing to ensure a watertight seal, and make good.

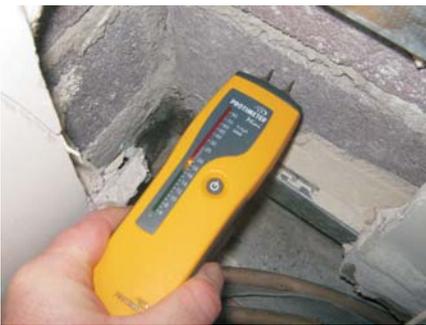
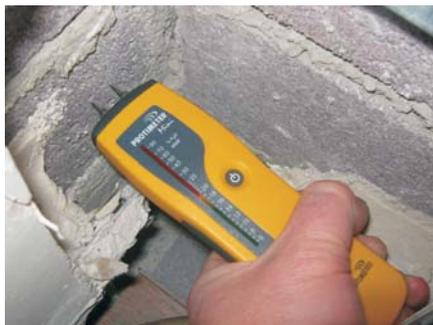
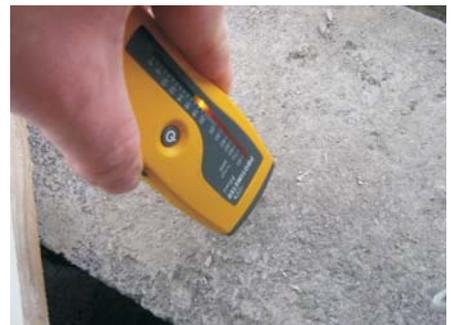
Inspection using a moisture metre has indicated moisture levels of 16-20% in the internal blockwork, and our client was forced to use a silicone sealant in order to attempt to seal some of the joints externally. (Typical dry reading is 8-10%)

Moisture readings 16 - 20%

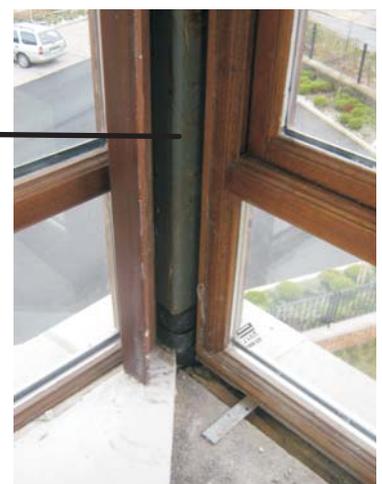
Silicone sealant to mortar joint as temporary repair by client

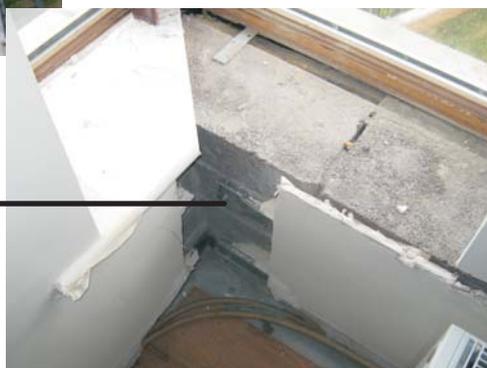
Our client was forced to remove the window board, and a portion of the dry lining to attempt to repair a leak at floor level.

Client forced to remove window board, and dry lining to attempt emergency repairs

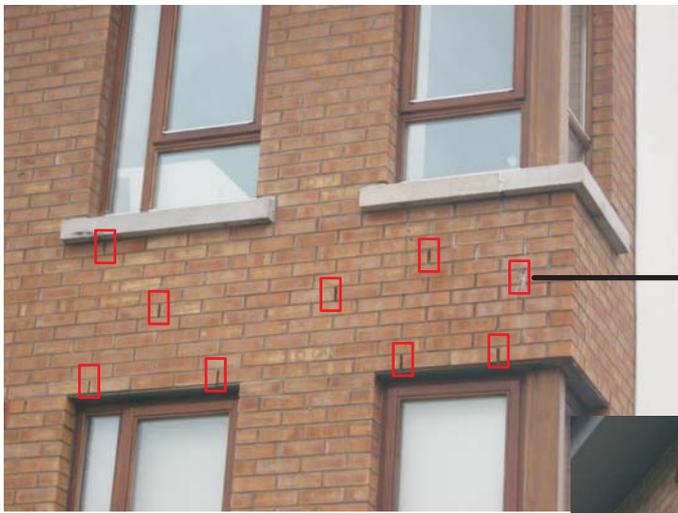
Subsequent investigation appears to reveal that a number of bricks on the outer leaf have no mortar between them, and water has entered through these joints by wind/capillary action.

No mortar in vertical jointing to brickwork at 9 locations beneath clients bedroom window

Examine all external brickwork throughout entire apartment, and check for loose/damaged mortar work, remove, replace and make good.

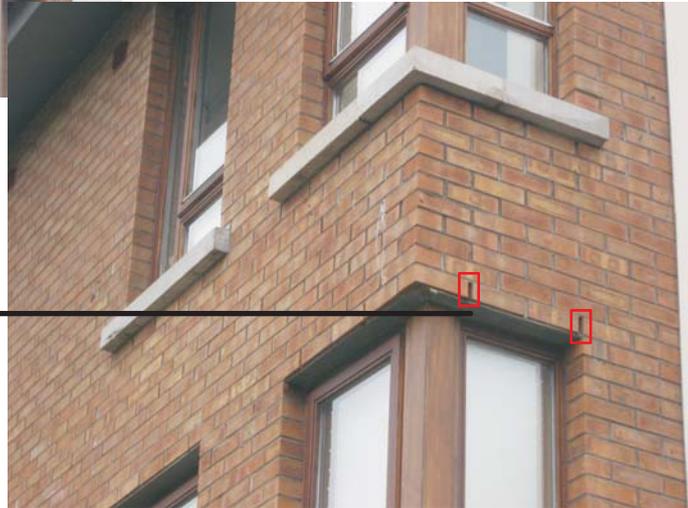
No mortar in vertical jointing to brickwork
