The information set out below must be read in conjunction with the marginal notes which form an integral part of the report. You are advised to show a copy of this report to your solicitor.

Report No. 45-15
Name of Client: xxxxxxxxxxxxxxxxxxxxxxxxx
Address of property inspected: Santry, Dublin 9.
Date of Inspection: 25th February, 2013.
Weather Conditions: Bright, Dry, & Cold

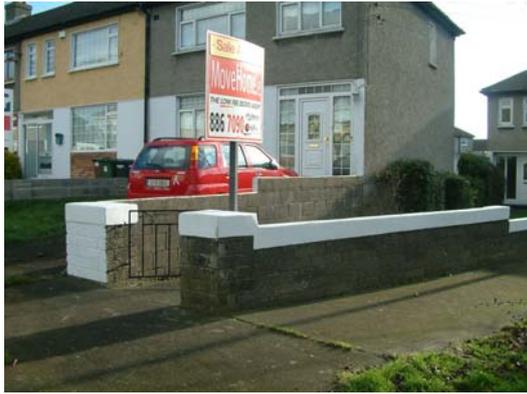
Block walls and piers to front garden in reasonable condition

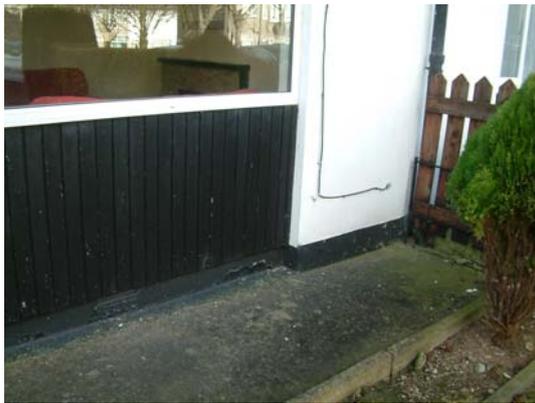
Timber panelling in poor/reasonable condition beneath front living room window, and loose cabling running through large hole in wall

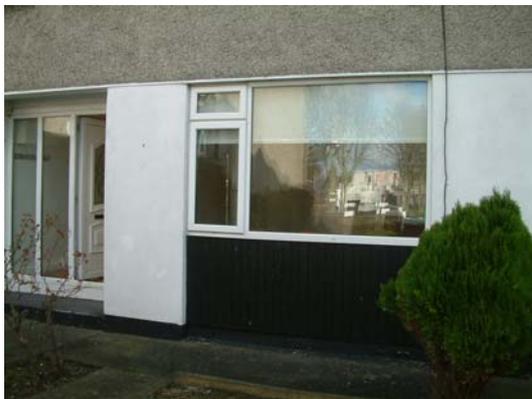
Upvc Double glazed window and front hall doorset with badly fitting opening sections

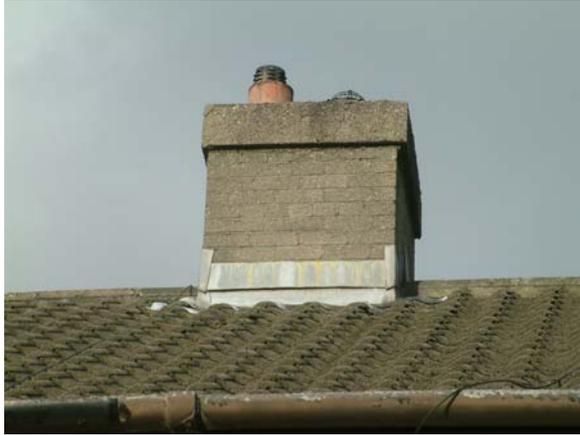
Chimney stack with flashing in reasonable condition.

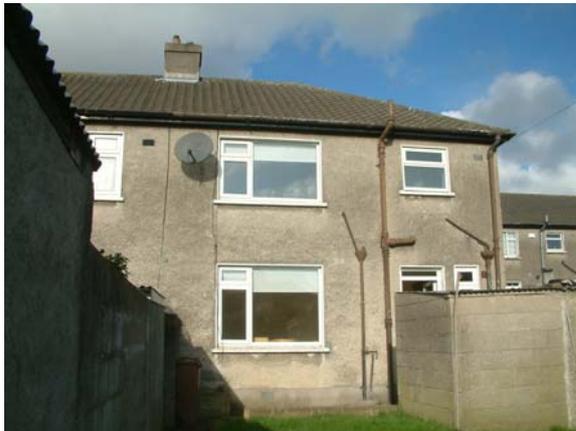
Pitched hip-ended roof with concrete roof tiles in reasonable condition.

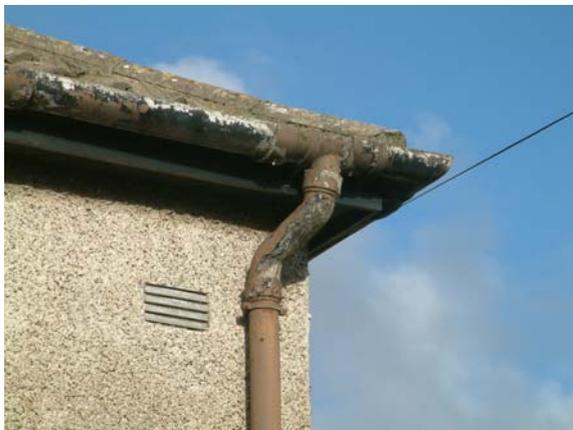
Timber fascias and soffits and cast iron rainwater goods in poor/reasonable condition.

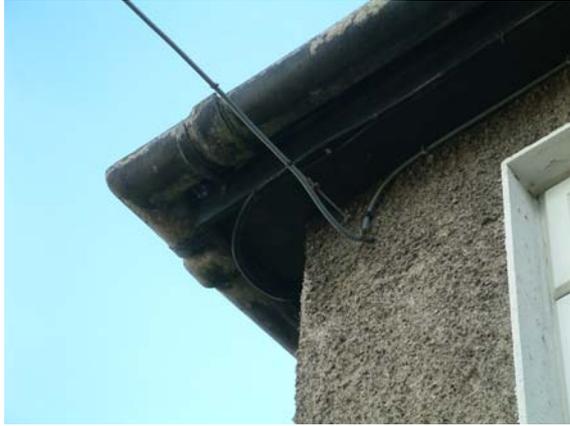
Timber fascias and soffits and cast iron rainwater goods in poor/reasonable condition.

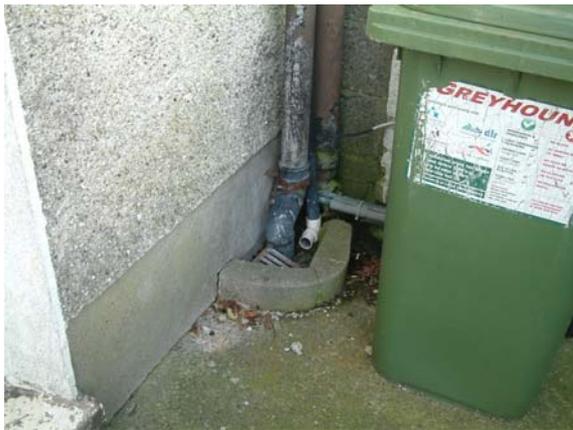
Cast iron rainwater goods in poor condition.

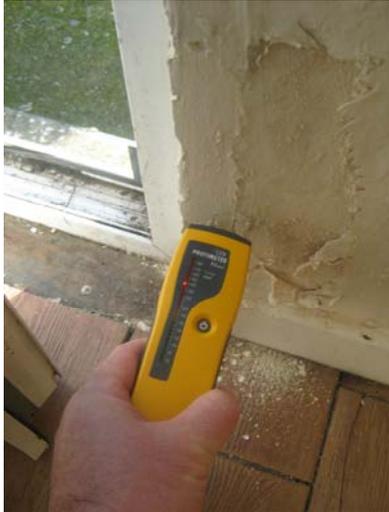
Damp wall adjacent to kitchen door/plumbing/stop cock

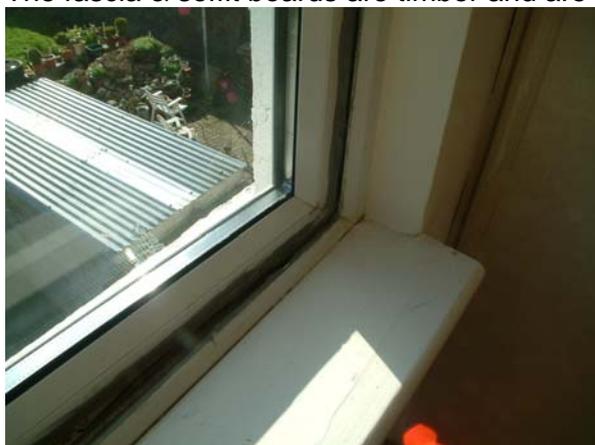
Badly fitting windows with evidence of flexible sealant being used to (badly)draught-proof the opening sections

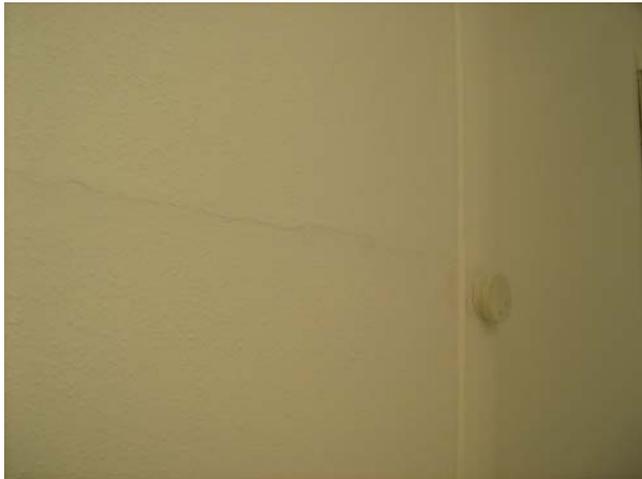
Typical plasterboard cracking throughout dwelling walls

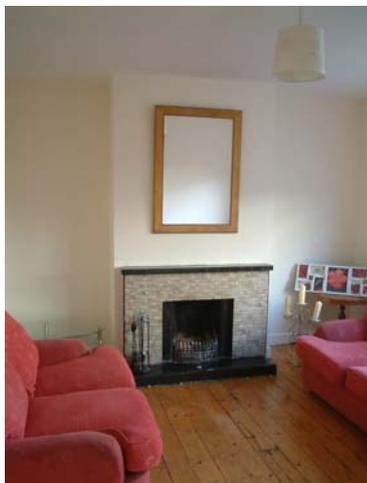
Living room fireplace in poor/reasonable condition

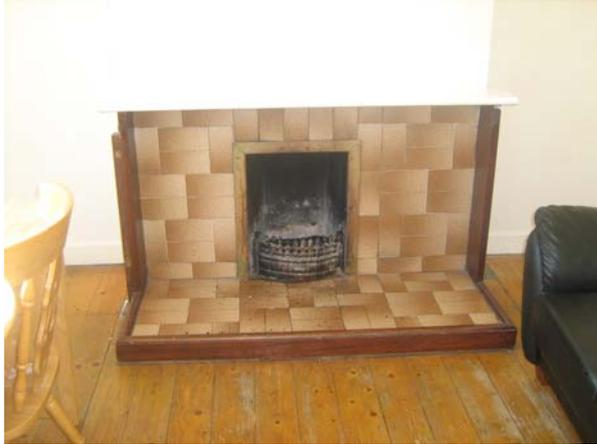
Kitchen/ Dining room fireplace in poor/reasonable condition

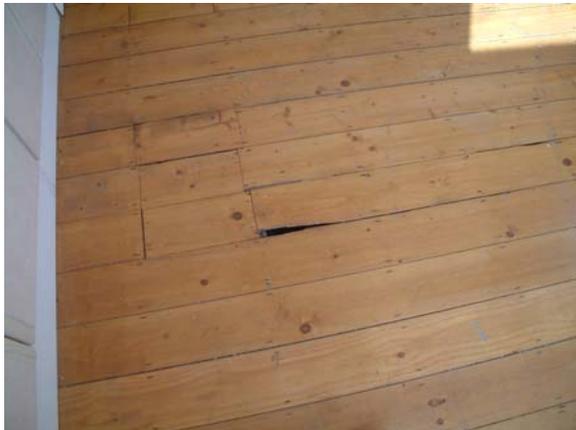
Floors have been stained and varnished throughout, and are in a poor state of repair with some holes evident, flooring having been damaged with prior renovation/heating system work.

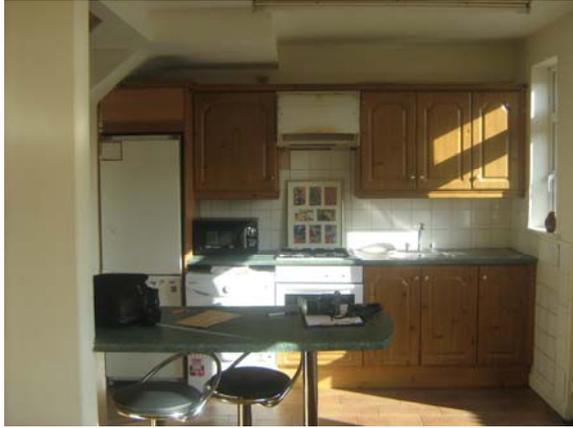
Kitchen units in poor condition

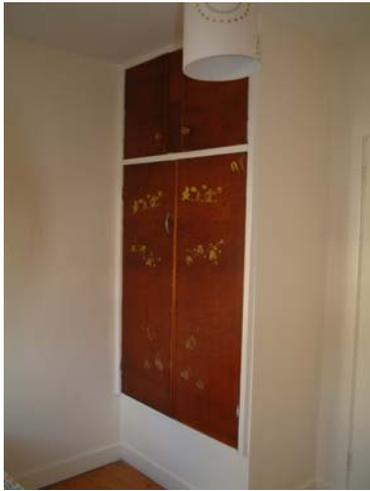
Box room fitted unit in poor condition

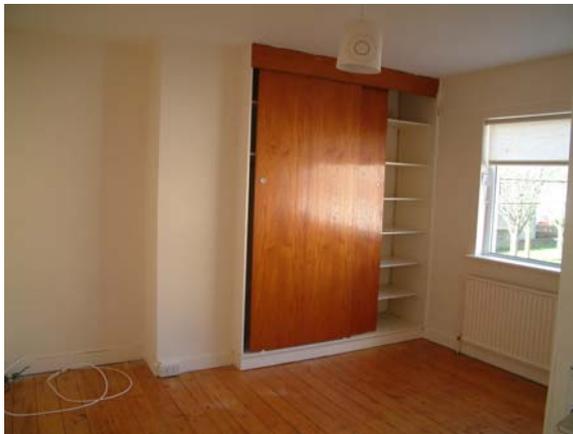
Double bedroom fitted unit in poor condition

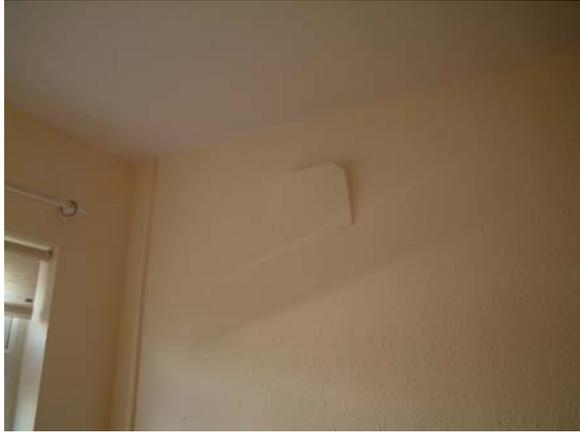
Room vent in box room

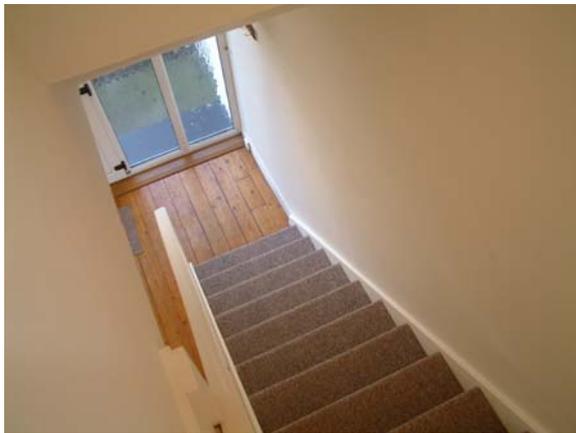
Timber floor finish to hall, and carpet to stairs all in poor condition

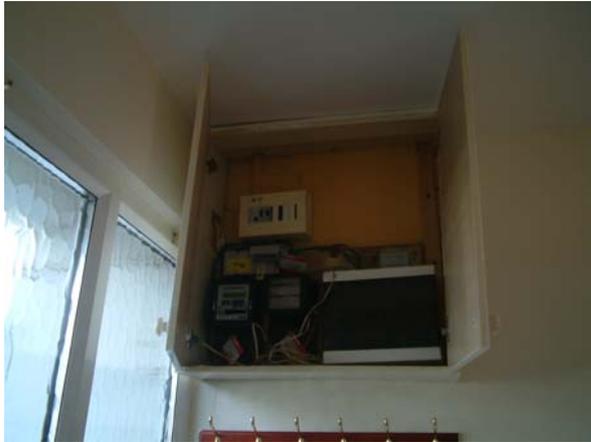
E.S.B. meter & E.L.C.B. board located
In wall press adjacent to front door.

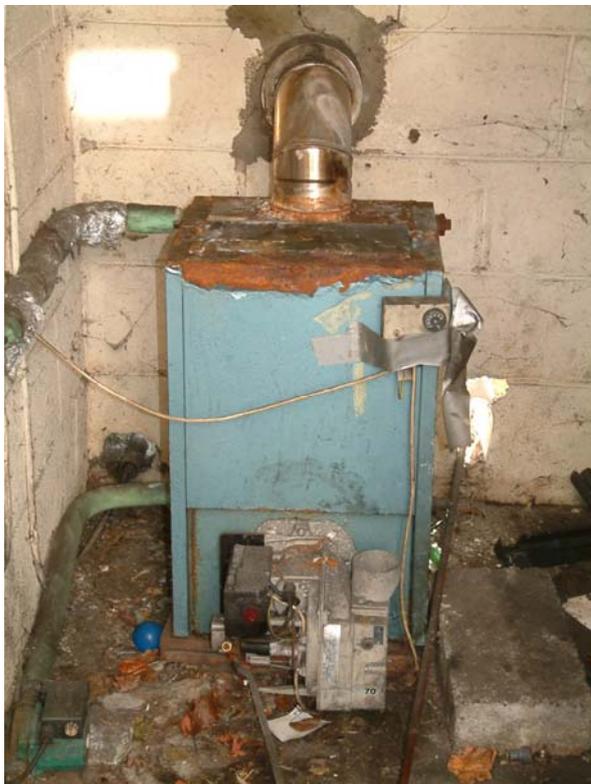
Old kerosene fired heating system located in
outhouse at rear of dwelling

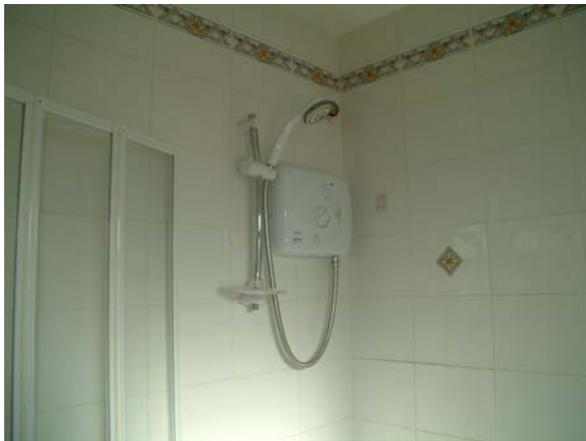
Bathroom tiling in poor repair with pumped electric shower installed (Triton T90)

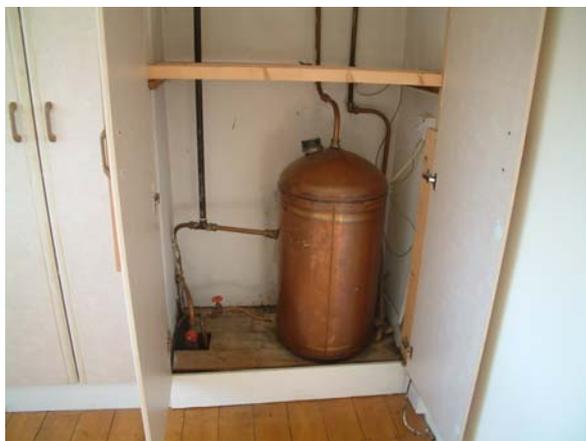
Old un-insulated hot water cylinder in double bedroom to rear.

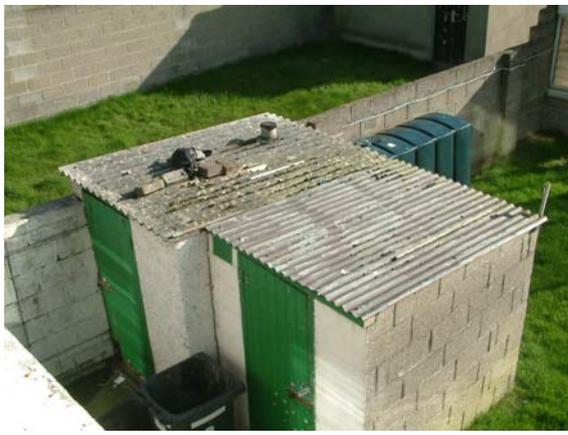
Outbuildings 1 immediately to rear of dwelling with asbestos roofing to boiler house (to be removed as part of any outbuilding renovation)

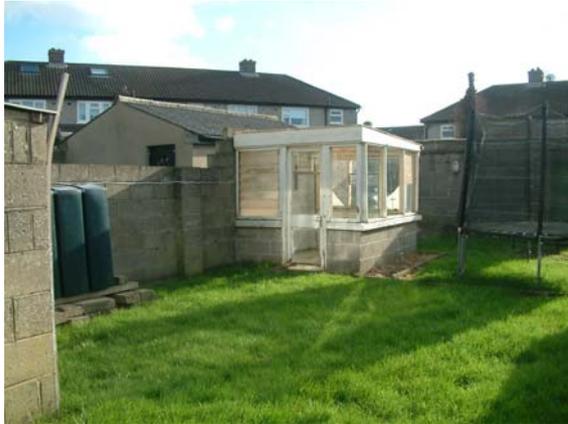
Outbuildings 2 – middle of garden - Flat-roofed conservatory in poor repair)

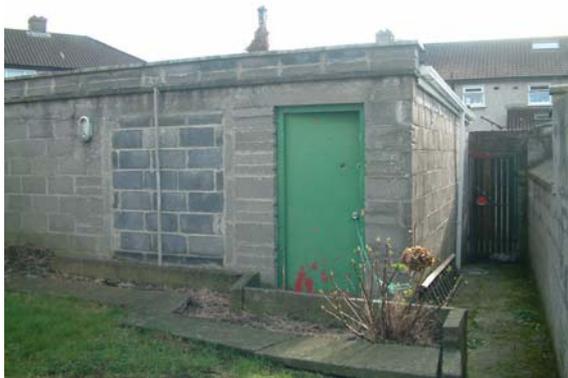
Outbuildings 3 – well constructed garage to rear of back garden with vehicular garage door to rear laneway

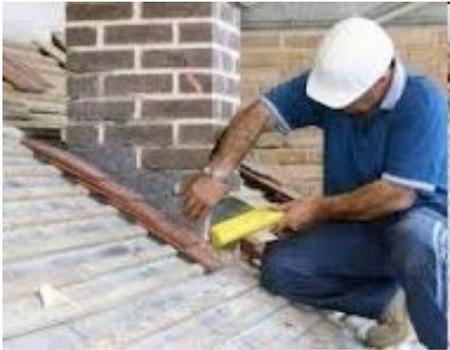
All older dwellings will suffer from roof damage given age, and need to be thoroughly **inspected by a competent roofing contractor**. Typically, any damaged/cracked slates or tiles need to be repaired or replaced, and all flashings around chimney breasts, valleys, valley gutters and any complex flashing details investigated and repaired as necessary.

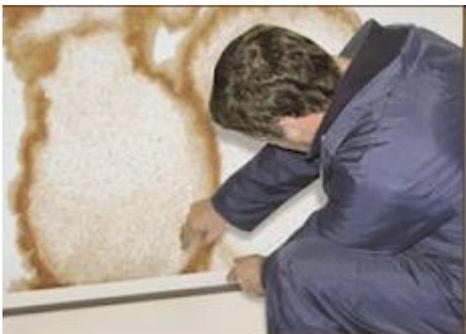
Investigate damp spots adjacent to kitchen door internally, remove all damaged timberwork, and plasterwork, repair and make good.

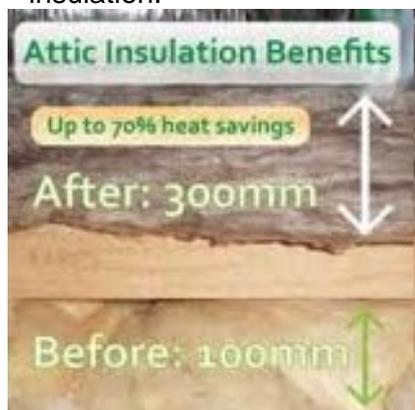
Increase your **attic insulation** as much as possible. As the adjacent advert suggests there are great savings to be made with the appropriate amount of insulation. Attic insulation is relatively easy to install, just make sure you are properly dressed in a protective suit with gloves, hat and facemask to prevent direct contact with the insulation. Also ensure that you do not close off ventilation from the eaves of your house – your attic needs ventilation too!

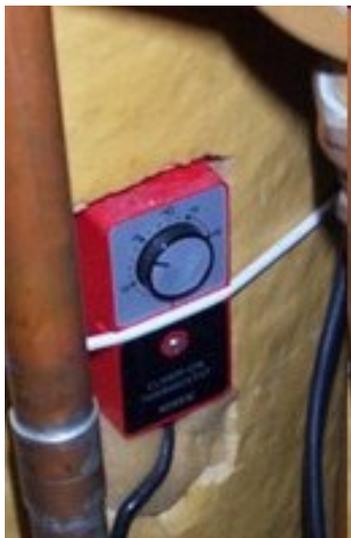
Fitting **thermostatic control** to your hot water cylinder increases the efficiency of your heating system, thereby saving you money.

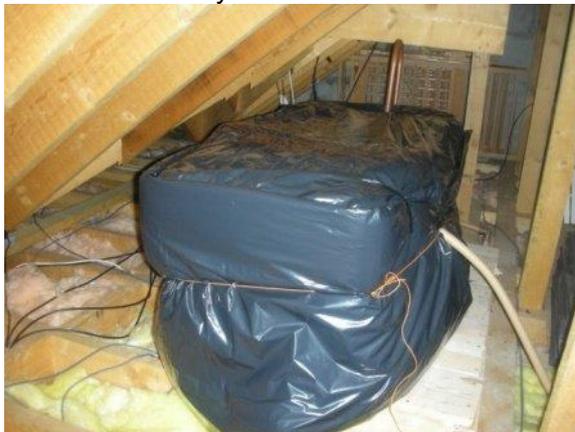
Insulated Attic cold water storage tank –

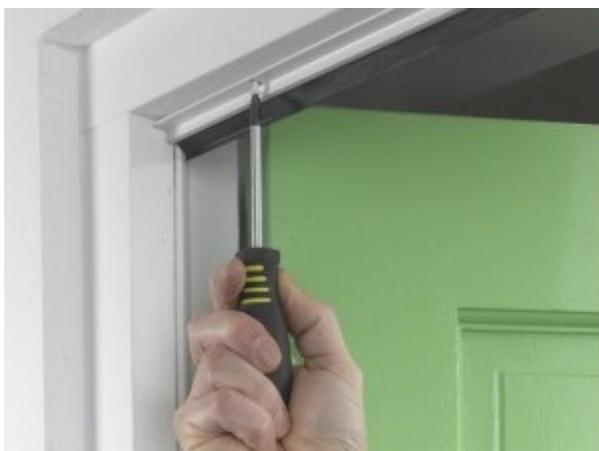
If you feel there are excessive draughts adjacent to windows and doors **Draught seal** around all external doors and windows as required. Employ a specialist to investigate your entire house. If possible try and identify the original manufacturer of the windows, and employ them to re-do the seals. (You may find their name in the spacer between the two panes of glass in your double glazing)

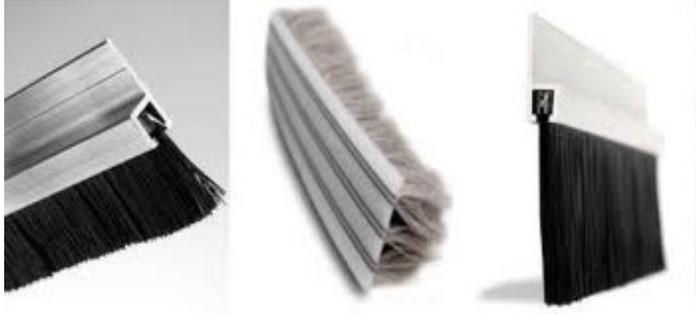
Draught Seals come in various shapes and sizes and are specific to locations in your windows and doors

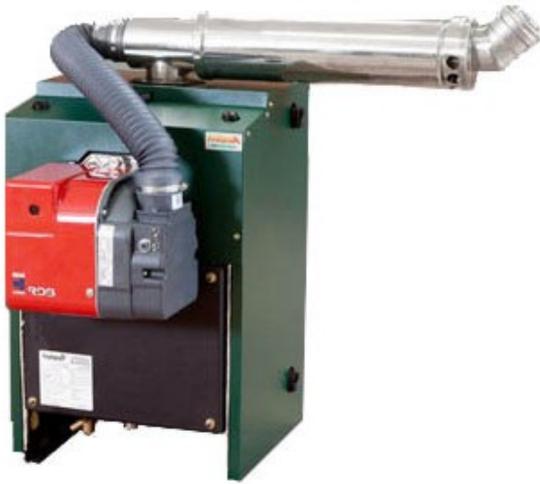
Replacing an old heating system with a **new condenser boiler** will reduce your fuel bill and ensure maximum efficiency (typically 92-96% efficient.) The condenser boiler re-cycles exhaust gases back through the boiler, extracting all the heat from them making it very efficient.

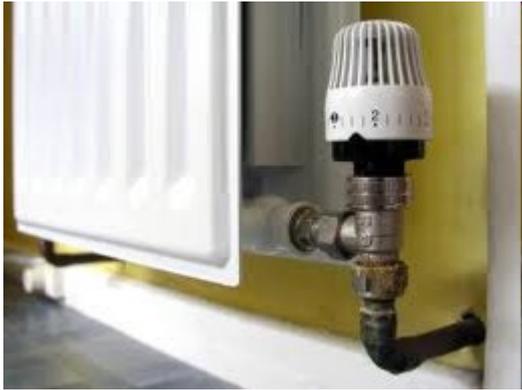
Fitting temperature zone control via **thermostatic radiator valves** also will improve the efficiency of your house. A thermostatic radiator valve (**TRV**) is fitted to every radiator in the house. By setting these thermostats to a comfortable temperature, you are keeping your heating system running efficiently thereby saving you money.

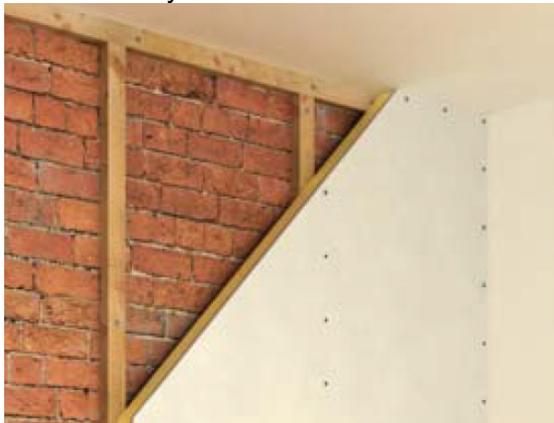
As part of a larger renovation project, **thermally insulating** the original walls of the house internally would make a major improvement to the overall efficiency and comfort of the home.

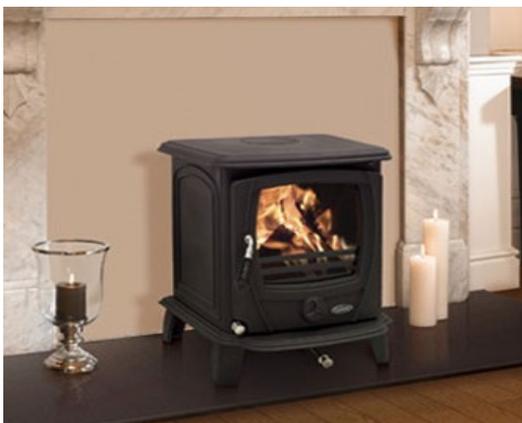
Freestanding Stoves allow all the air surrounding the stove to heat up giving maximum return for your fuel. Stoves can come in traditional form such as the Waterford Stanley unit in the photograph, but can also be very contemporary looking (See Jotl stoves as an example) Stove efficiencies can be anything from 60% upwards as against 30% for an open fire.

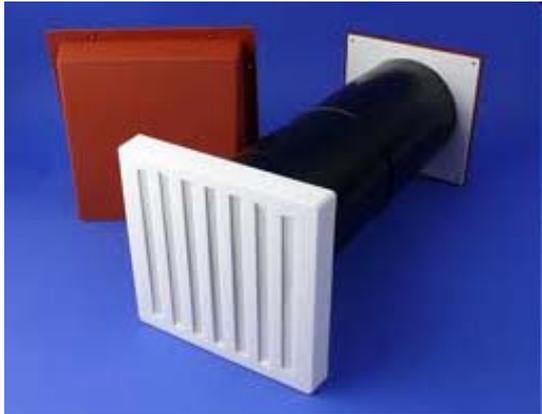
All rooms require ventilation, and installing the appropriate **room vents** ensures adequate ventilation. The vent shown in the picture costs typically €20 – 25 and has an internal sleeve, which is cut to the appropriate length, and when fitted in to the wall ensures no air is escaping into internal wall cavities or behind dry-lined insulated walls. Inadequate ventilation may lead to the build up of condensation visible as mould spores and damp on walls. This too can lead to respiratory infections.

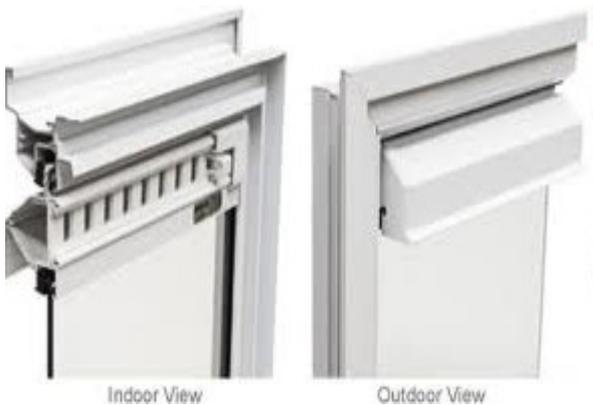
If you are considering replacing windows and doors throughout the house, insist on **window trickle vents** being fitted in to the windows as an **alternative to wall vents**. Trickle vents meet your required ventilation compliance, and are generally much more controllable and visually more discreet than wall vents.

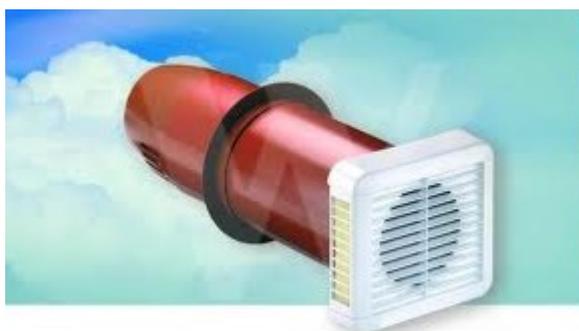
Ensure that **mechanical ventilation** is fitted to your bathroom with the extract fan set on a delayed time switch to allow it to run for periods of up to 10 minutes after the bathroom is vacated to ensure maximum extract of moisture laden air.

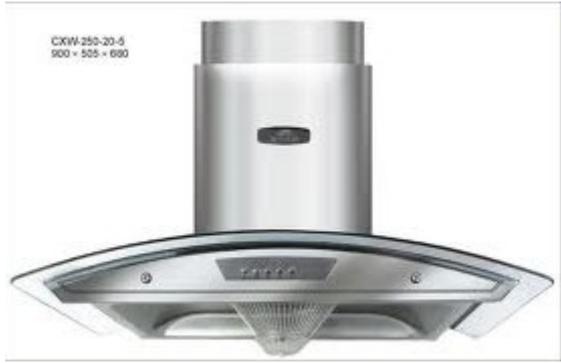
If you are considering replacing your kitchen, ensure that any cooker hood fitted as part of the upgrade is **mechanically ventilated to the outside**, directly through the wall behind the hood, or alternatively using a flexible hosing to the nearest external wall via ceiling joists or across the top of kitchen units.

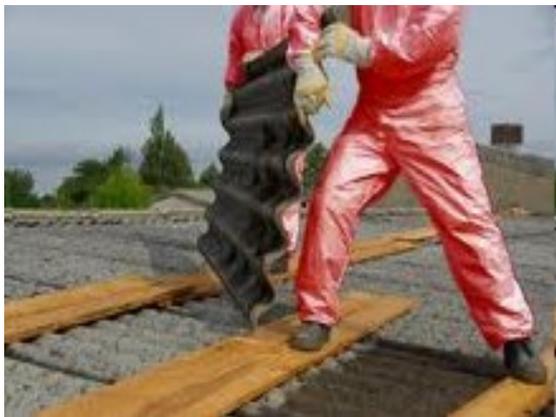
Asbestos is a well documented hazardous material, but especially so if it has been broken or damaged. We recommend immediate removal by a **suitably qualified asbestos removal company** that will give the required **removal certification** on completion.
