This inspection report is to provide a report on the general state of repair of the property described below. It is not a Full Structural Survey as it is not practical to examine unexposed or inaccessible areas of the property, but it is a report by the surveyor on those matters expressly set out in this report to establish the general state of repair and the structural condition of the property based on the visible elements as outlined in the report, together with valuation advice. This report will not detail defects of no structural significance, of minor significance, or in unexposed or inaccessible areas as it is a report on the visible surface only. This report does not check for pyrite, Woodworm/insect related damage or the presence of Japanese Knotwood. It does not check for rodent infestation in difficult to reach/unsafe areas of the building including attic spaces. The report does not refer to floodplain mapping or 1 in 50 or 100 year extreme weather events or recent extreme weather events in reference to flooding liability or regularity. The report does not consult local authority water services drawings to establish if local authority drainage traverses the property whic

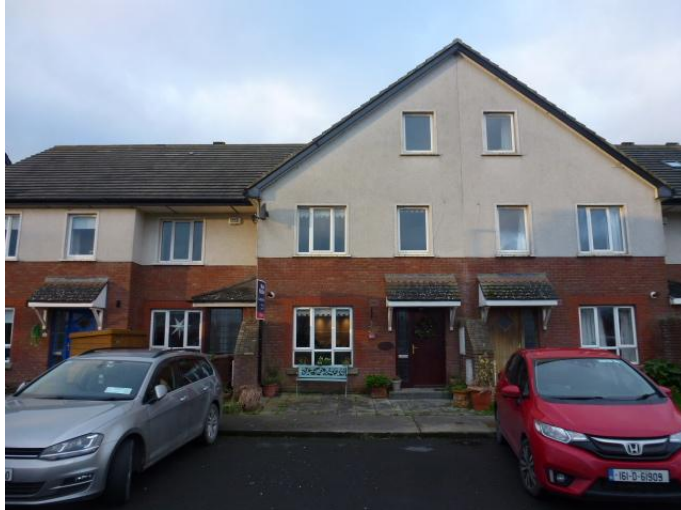
Brick/render finish to front elevation in reasonable condition

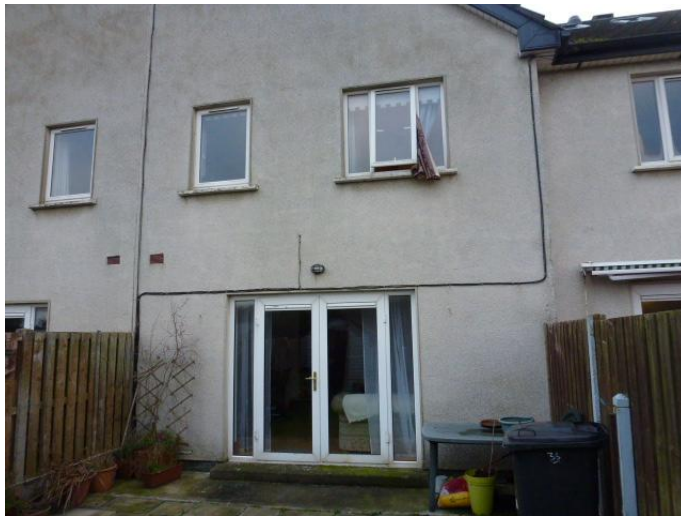
Render finish to rear elevation in reasonable condition

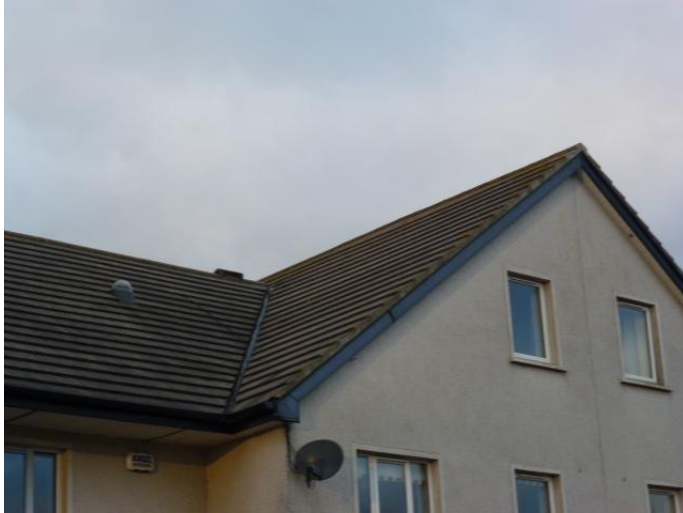
The roof vent tile appeared to be in reasonable condition given age. We would recommend that the capping, and mortar joints be checked for any moisture ingress, and repaired as necessary.

Front elevation – vent tile/flashings in reasonable condition

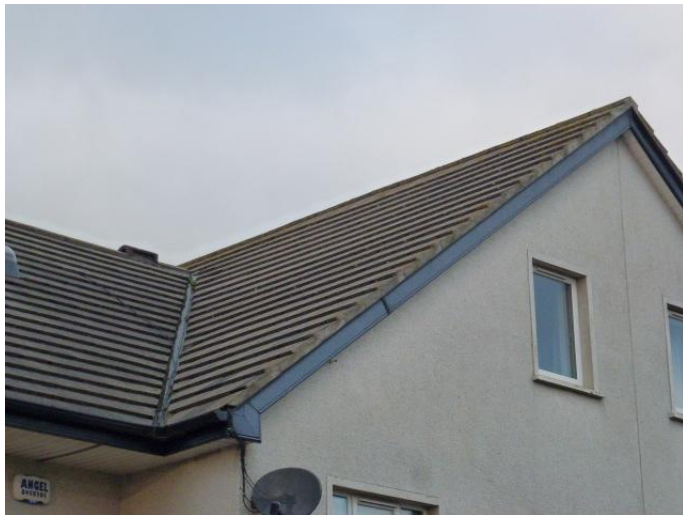
uPVC fascias and soffits in reasonable condition

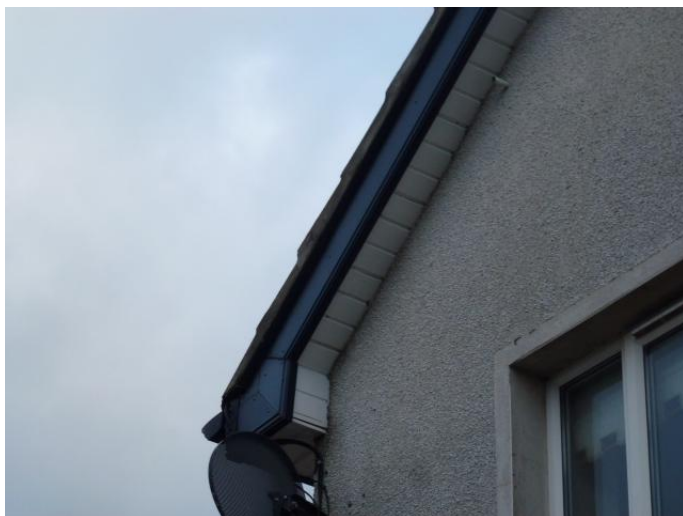
uPVC fascias and soffits in reasonable condition

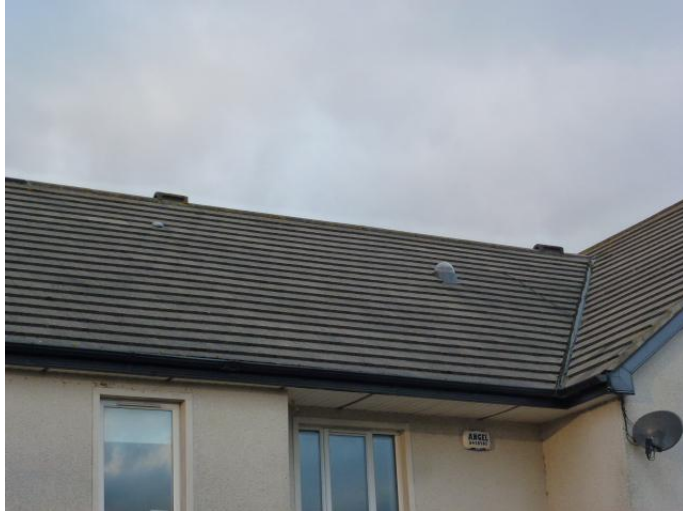
Roof fabric in reasonable condition

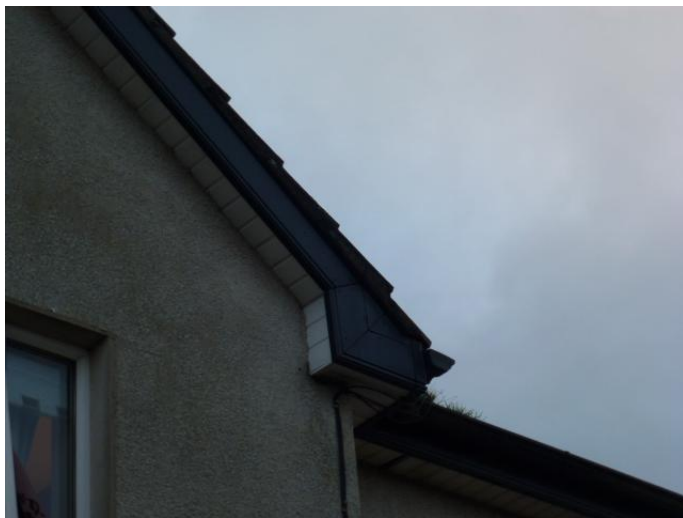
Rain water/soil goods in reasonable condition

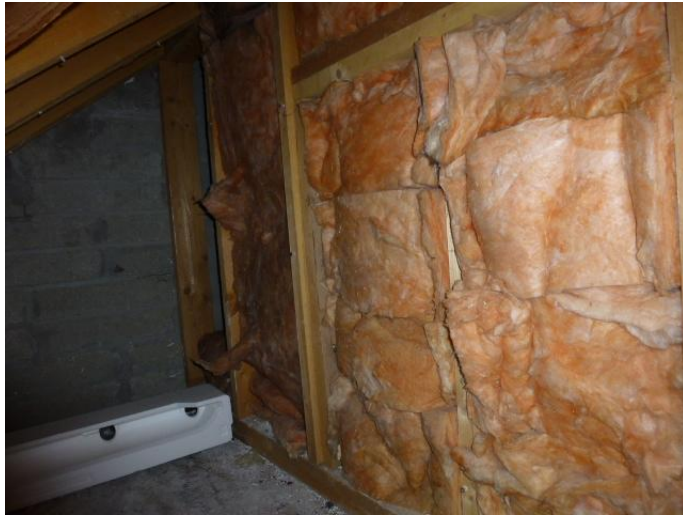
There is insulation evident fitted between the ceiling joists.

Attic photograph – insulation evident

We would advise that the roof space is always fully insulated to a basic min. of 300mm quilt insulation in accordance with Part L of the Building Regulations 2016. We would also advise that the cold-water pipes, and storage tank be fully insulated.

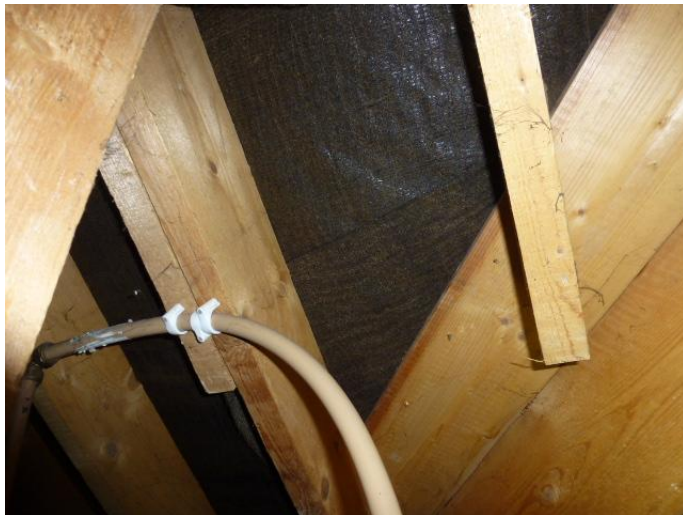
Attic photograph – sarking felt beneath rafters

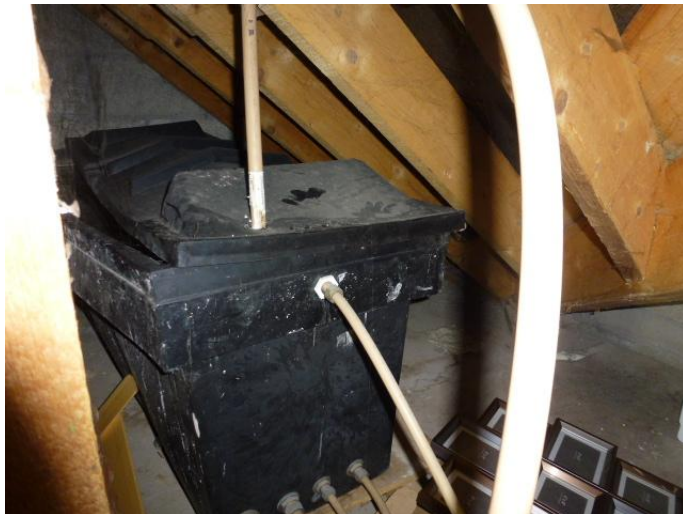
The cold-water tank and associated piping have been partially insulated.

Attic photograph – cold water tank

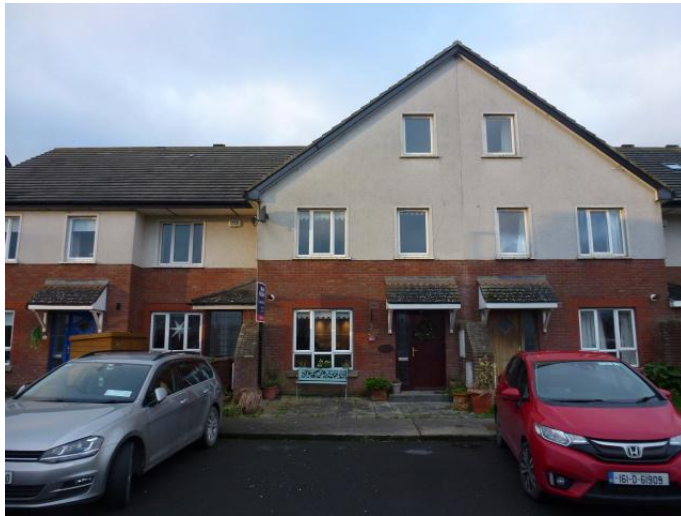
Brick/render finish to front elevation in reasonable condition

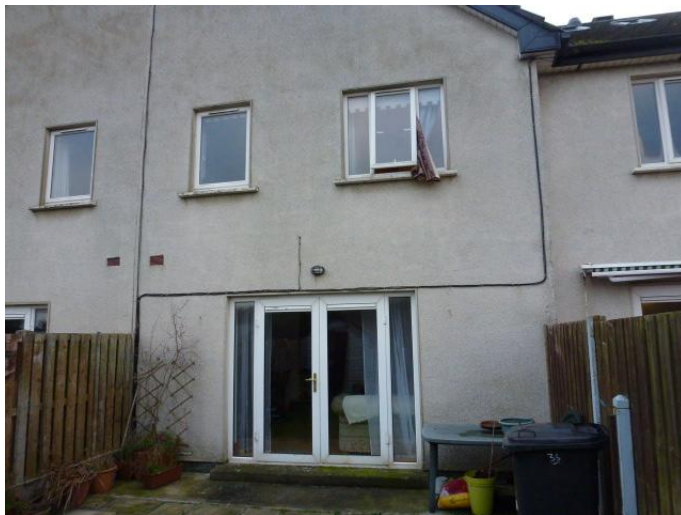
Render finish to rear elevation in reasonable condition

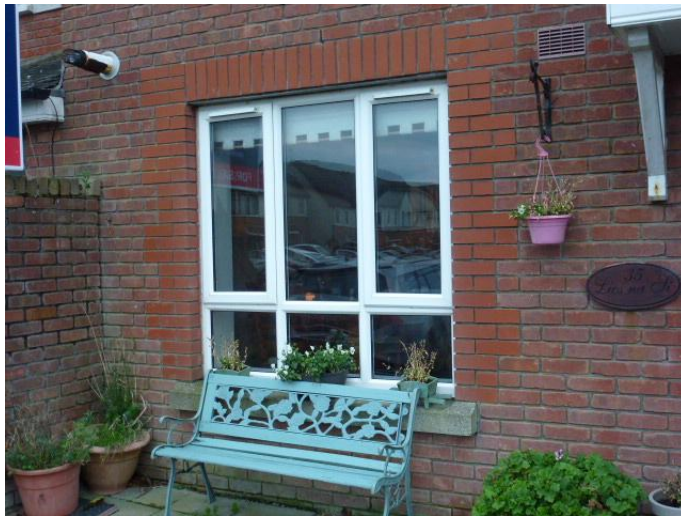
Front windows in reasonable condition

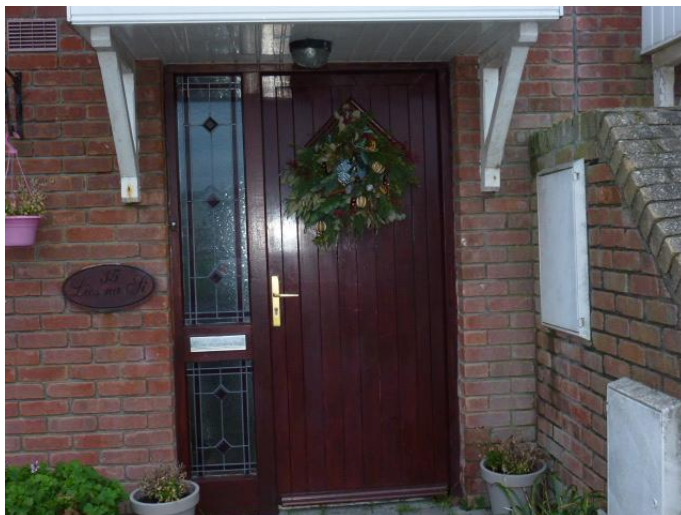
We noted the draught seal around the front door will need to be replaced.

Front doorset in reasonable condition

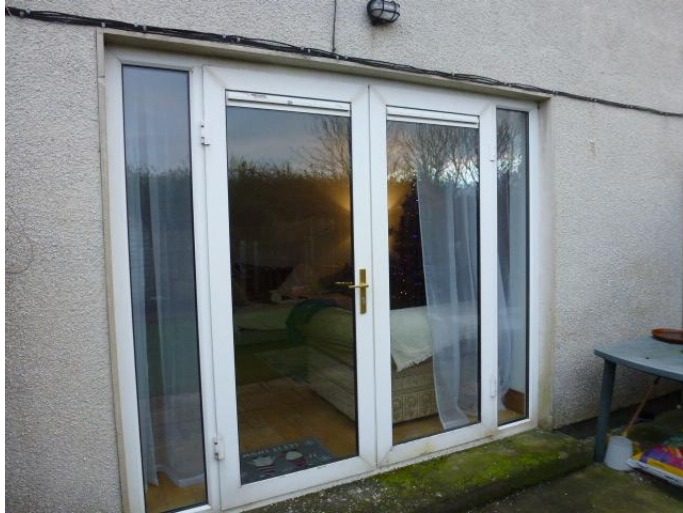
Rear doorset in reasonable condition

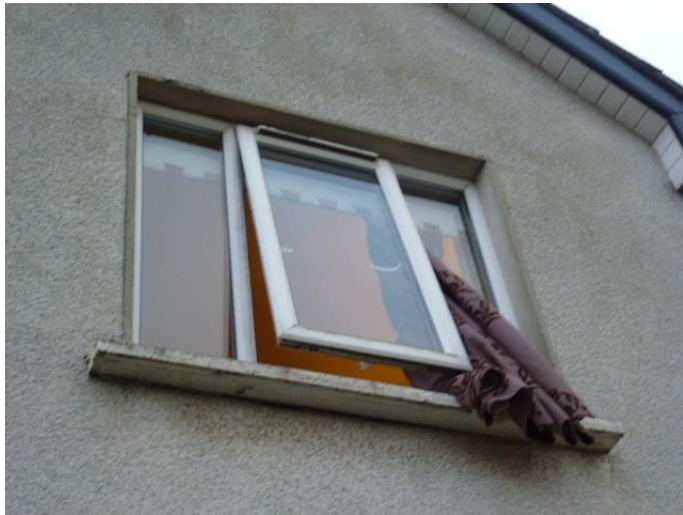
Rear windows in reasonable condition

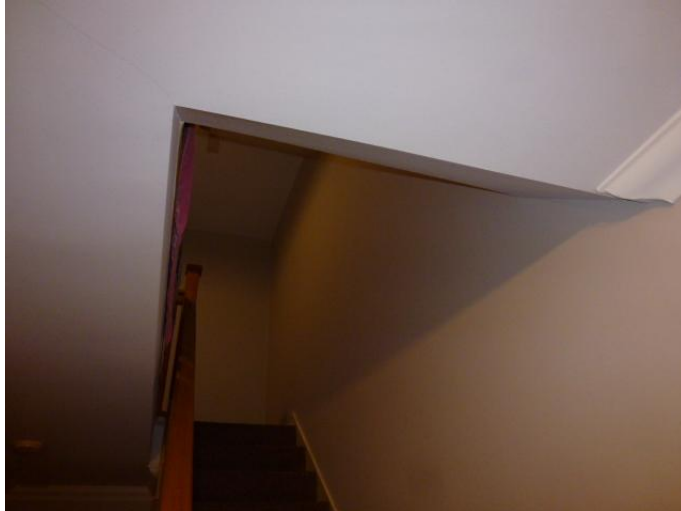
We noted very small cracks in plasterwork in locations throughout the dwelling.

These appear to be cosmetic and would be the norm for a dwelling of this age and are relatively easily repaired.

Plaster finishes in reasonable condition

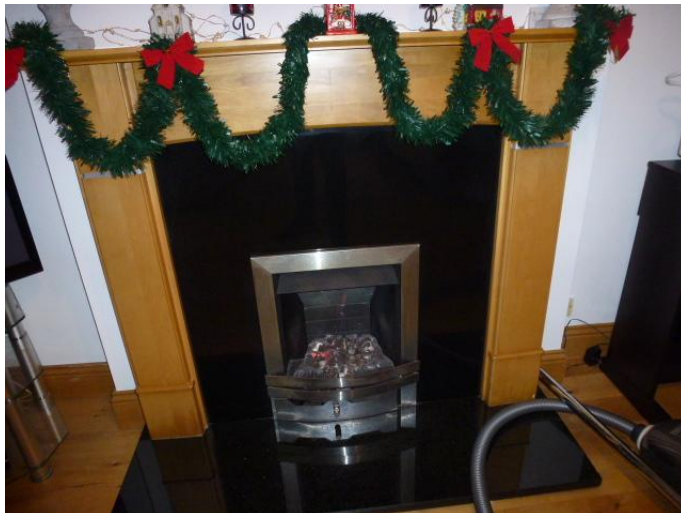
Fireplace in reasonable condition

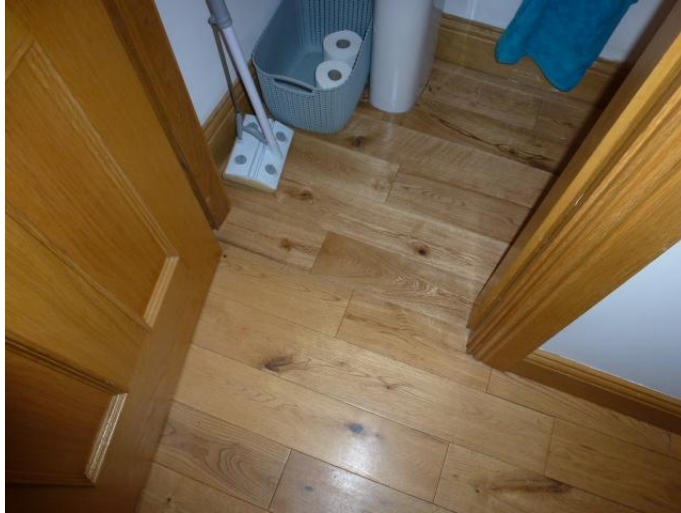
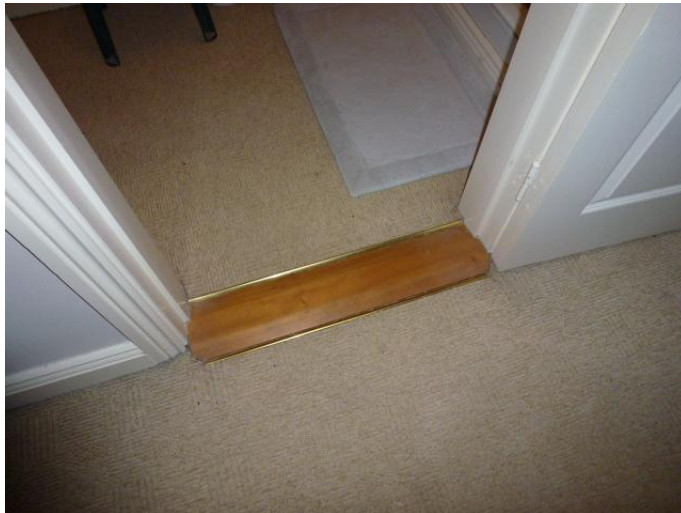
Floor finishes in reasonable condition

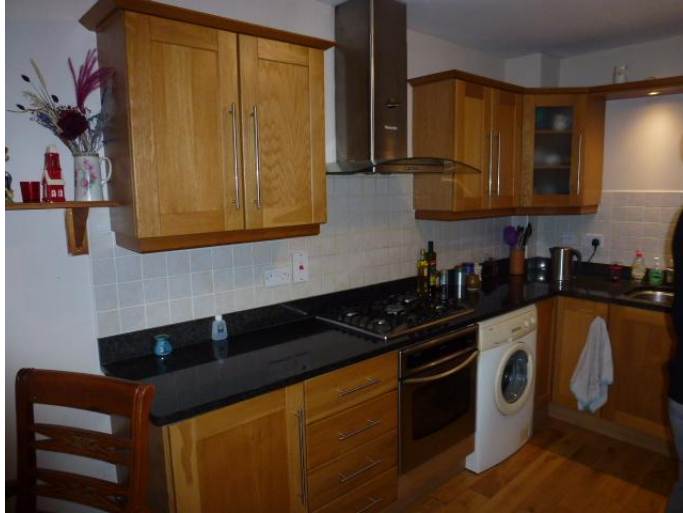
Kitchen units in reasonable condition

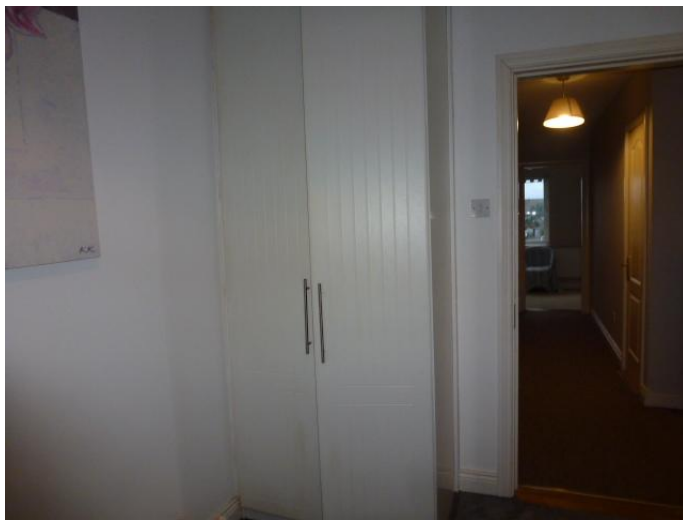
Bedroom units in reasonable condition

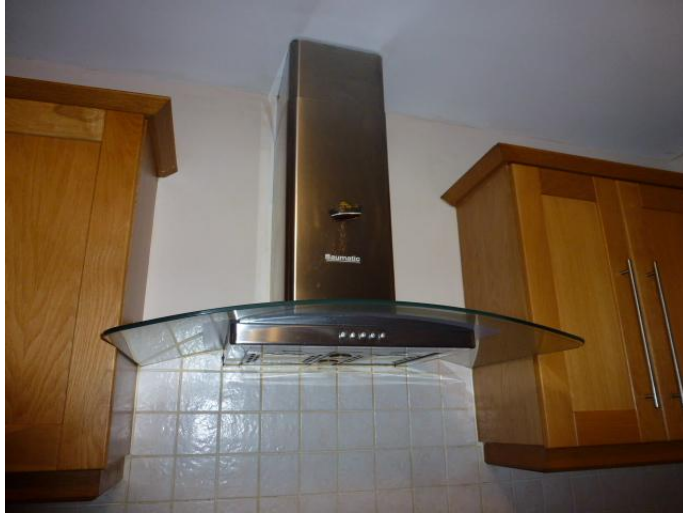
Mechanical vent to kitchen

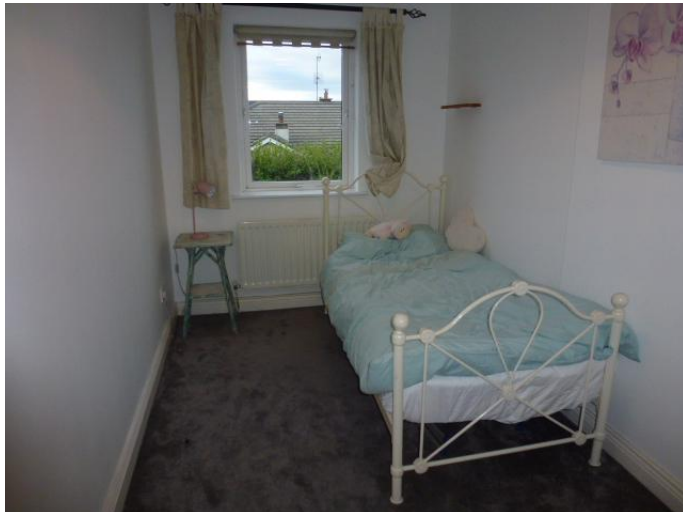
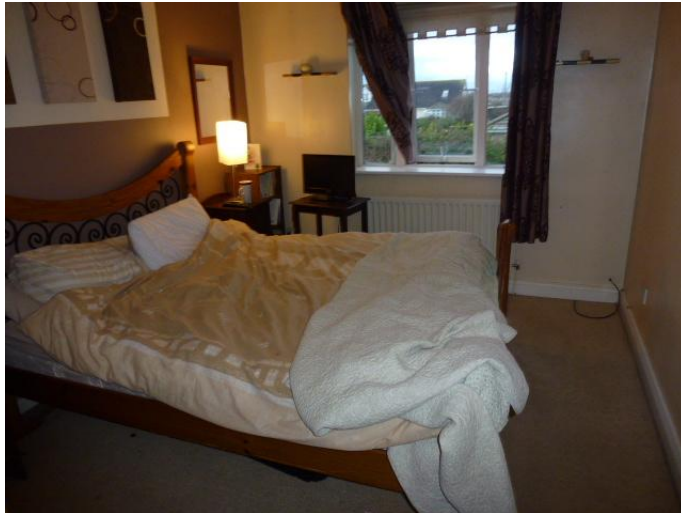
General finishes in reasonable condition.

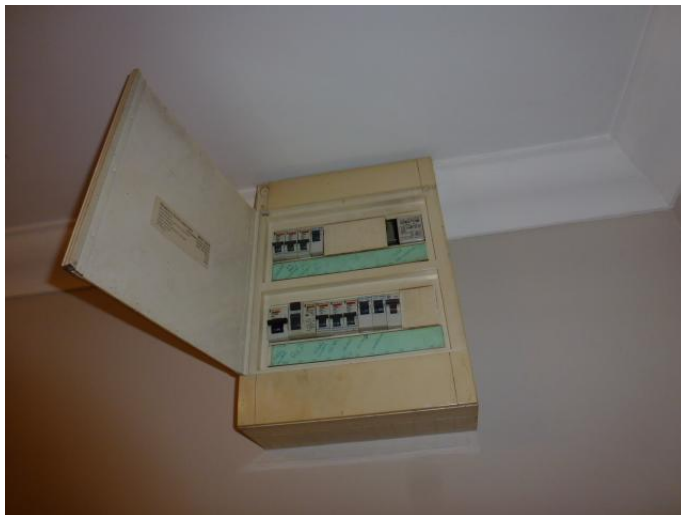
M.C.B. fuse board

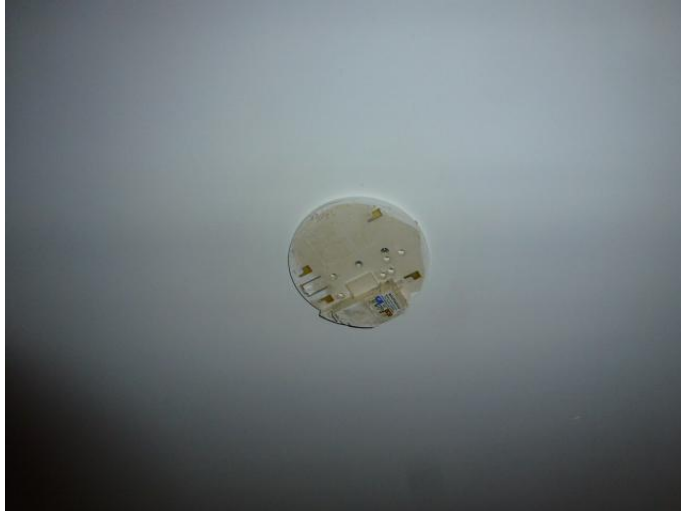
We noted a missing/disconnected smoke alarm in the living room.

Fire detector – living room - removed

3. Powerhose all existing fascias and soffits, inspect for any damage, repair and make good.
4. Repair/reinstall missing smoke alarm unit and make good.

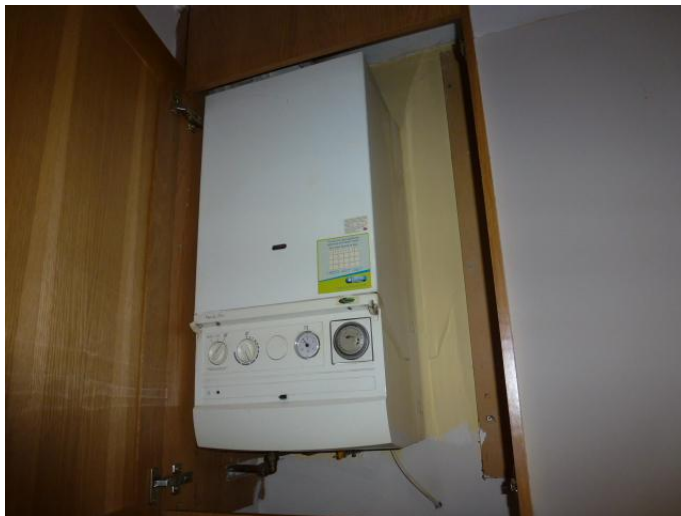
boiler in kitchen unit

We would recommend that a qualified central heating fitter conduct a maintenance report on the heating system as a matter of general safety.

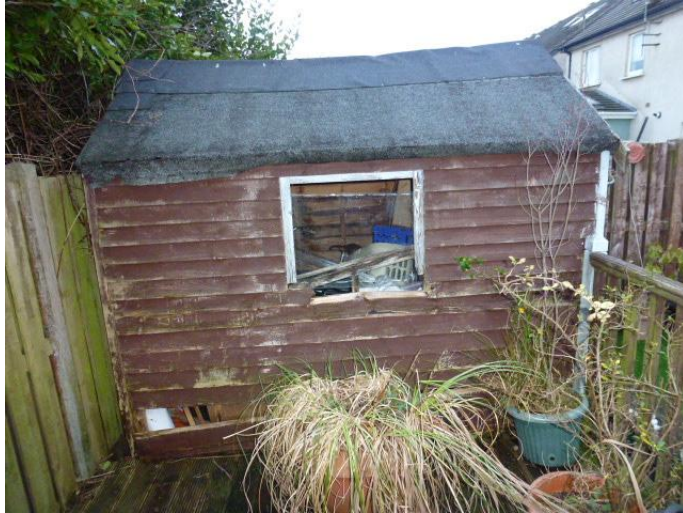
There is a timber shed to rear which is in reasonable/poor condition.

We noted some of the timber was damaged and the window was damaged on the day of inspection

Timber shed in reasonable condition.

7. Clean moss from timber decking to rear garden and make good.
8. Repair damage to timber shed and make good.
9. Repair any cosmetic cracks to ceilings and walls throughout prior to repainting.
