Report No. 43-02

This report has been prepared to ascertain the current condition of the existing roof to the building, and recommendations for possible replacement, and/or repair of same.

The building in question is a three storey apartment block constructed in the late 1960's / early 1970's. The roof is of flat roof construction.

Report No. 43-02 - ADDENDUM

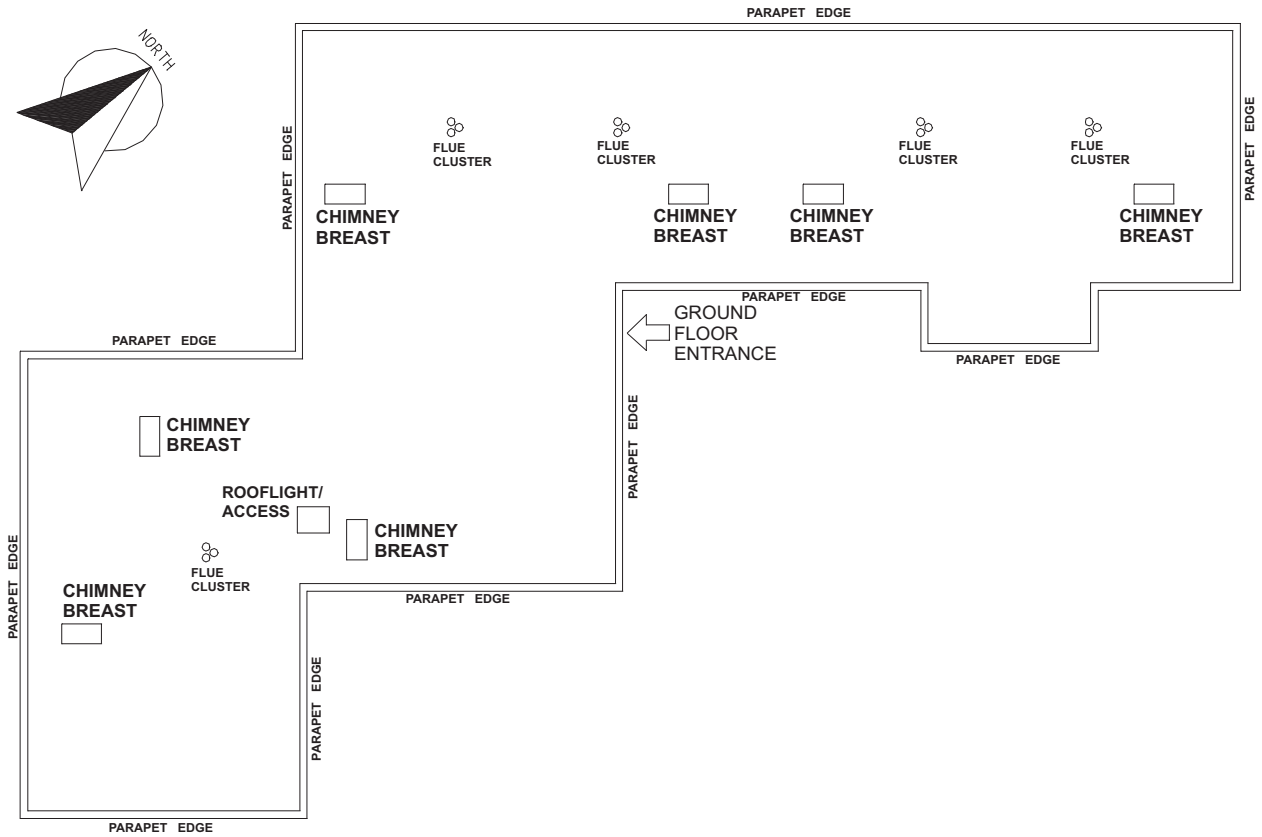
APARTMENT SCHEME ROOF PLAN/PHOTO KEY

The following page is a visual photograph survey of the roof, indicating damaged areas.

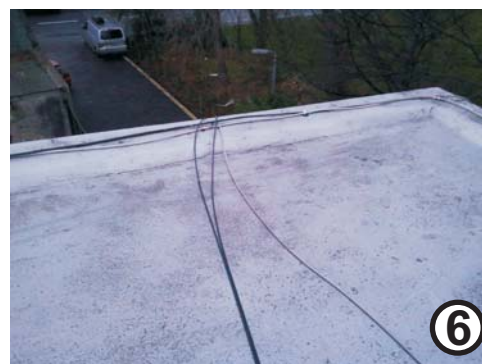
Cracking is also evident at various locations on the roof, and around the parapet wall detailing, with some repairs evident. Conditions on the day of inspection were dull and wet.

The wet surface may have partially obscured other cracks, therefore the locations indicated below are not exhaustive.

It is our opinion that the roof finish may be ending its useful life, as the amount of cracking visible suggests.

We would therefore recommend that the roof be replaced in its entirety with a similar equivalent. This would typically be 2no.layers of torch on felt dressed up around all chimneys, fixtures and fittings and suitably flashed. Application of a layer of reflective paint too will extend the life of the roof material.
