**Report No.** 42-07

**Address of property inspected:** xxxxxxxxxxxxxxxxxxxxxxxxxxxxxxxxxxxx

**Date of Inspection:** 1st February, 2013.

This report has been prepared to ascertain the source of damp patches occurring in the bedrooms and living rooms of nos. xxxxxxxxxxxxxxxxxxxx, and the presence of structural damage in bedroom 2 of xxxxxxxxxxxxxxxxxxxx

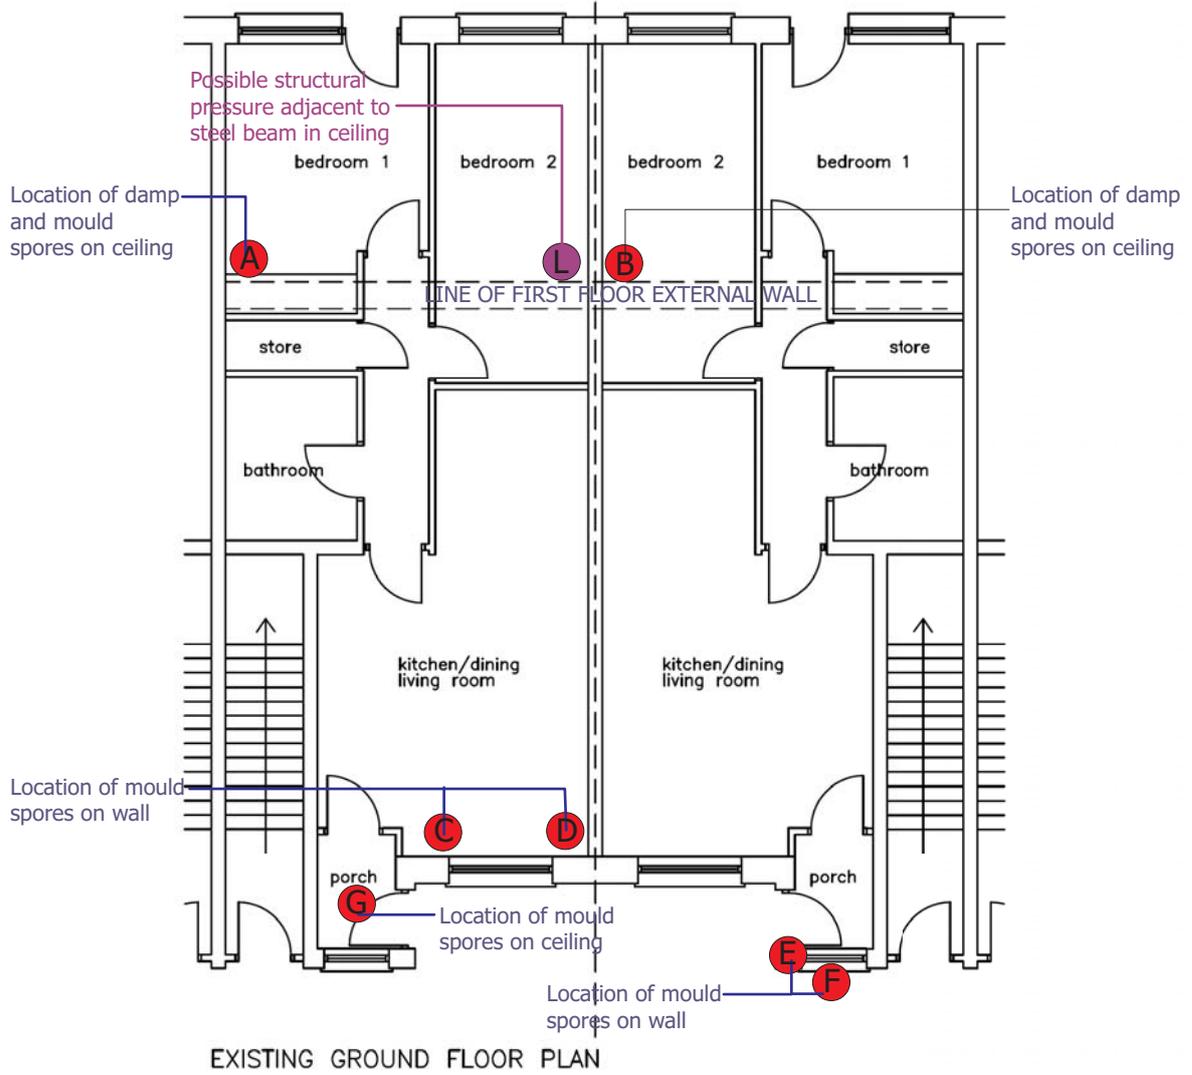
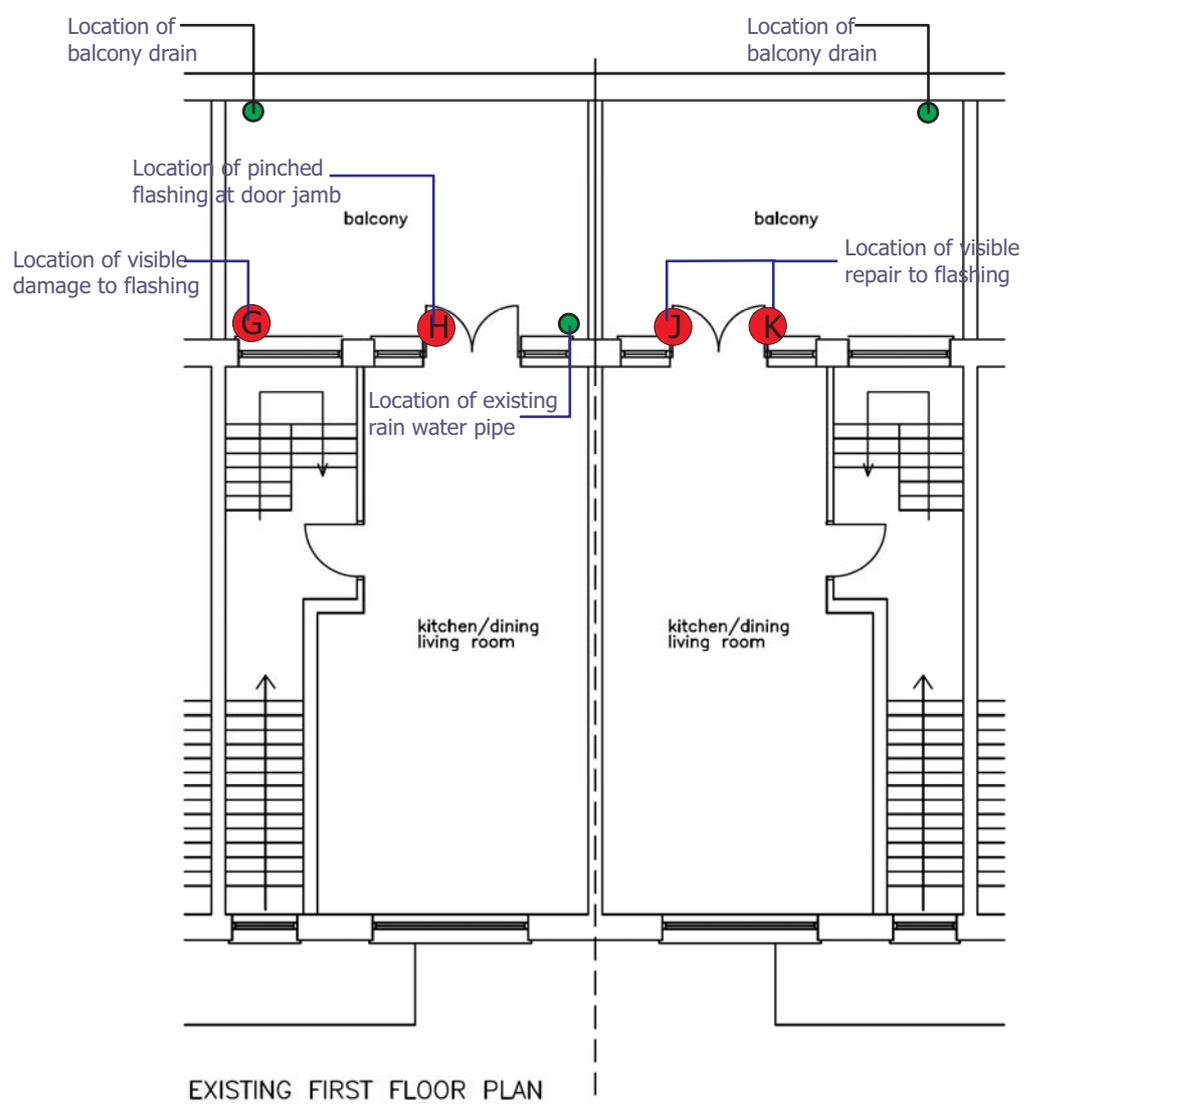
The diagram on the previous page (page 2) of our report indicates the ground and first floors layouts of the apartments and also indicates the key locations of visible damp areas and visibly damaged external flashings as indicated by our client.

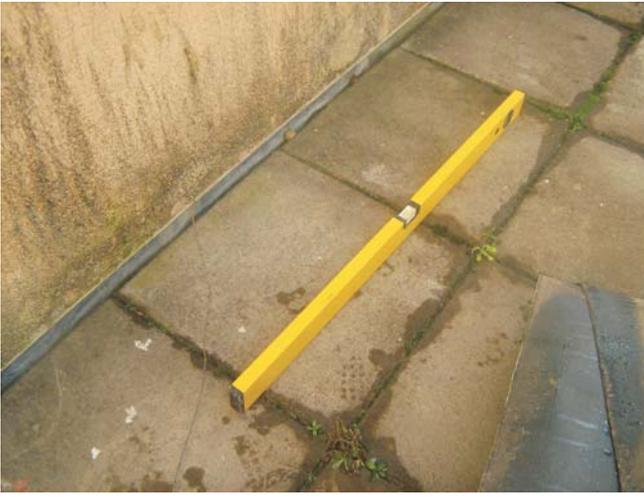
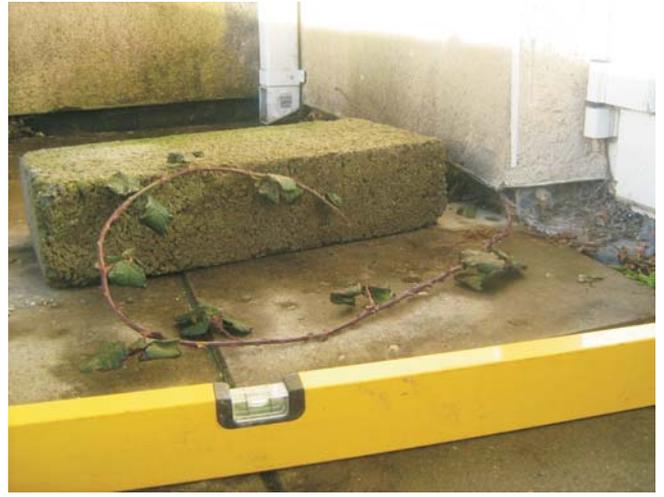
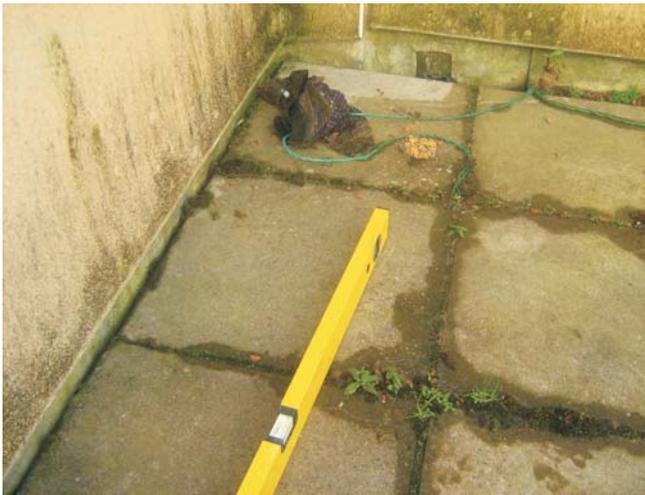
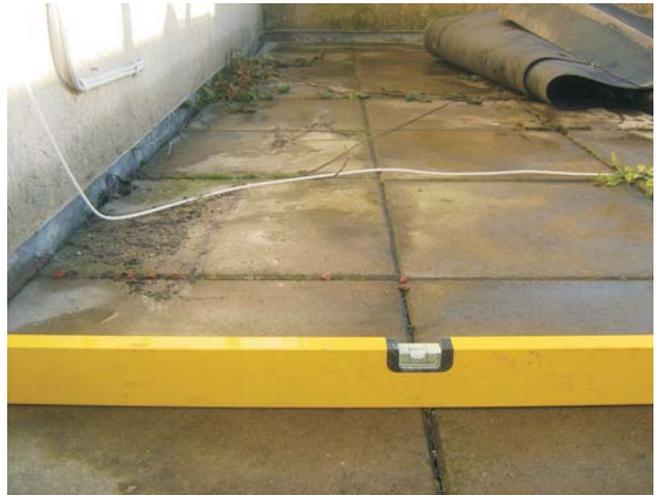
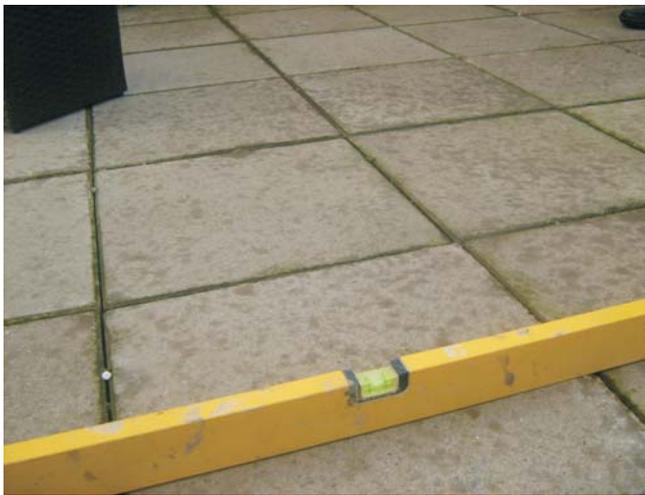
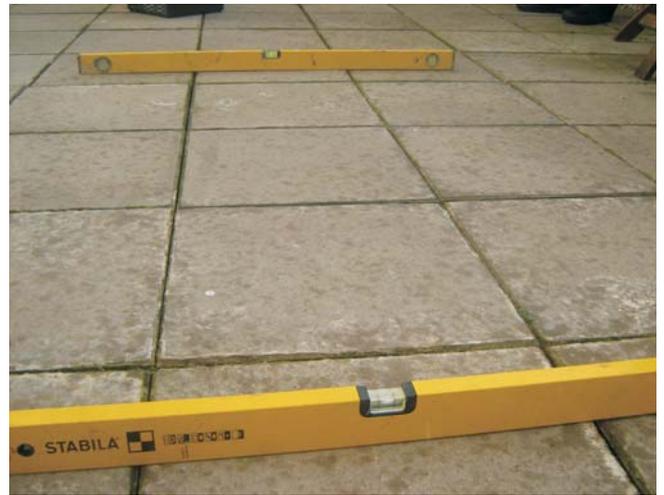
On examining the flat roof to the balconies to apart nos. 1 & 3 respectively, we noted that the construction appeared to be concrete roof tiles fitted on top of a heavy duty waterproof membrane.

It was noted that the the concrete roof tiles appeared not to be laid to a fall as the spirit level showed a horizontal position at locations checked on both balconies.

We feel that due to a lack of fall to the intended drains on both balconies, during a period of extended, or heavy rain, this could lead to a significant ponding of water on the balconies.

We noted that the perimeters of the balconies were filled with fine draining stone, but no suitable grills had been placed at the drain points, effectively clogging these, and as a result this would slow down the escape of water from the balconies.

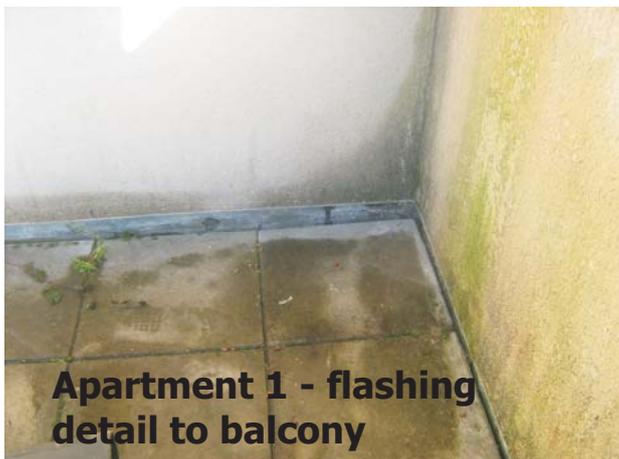
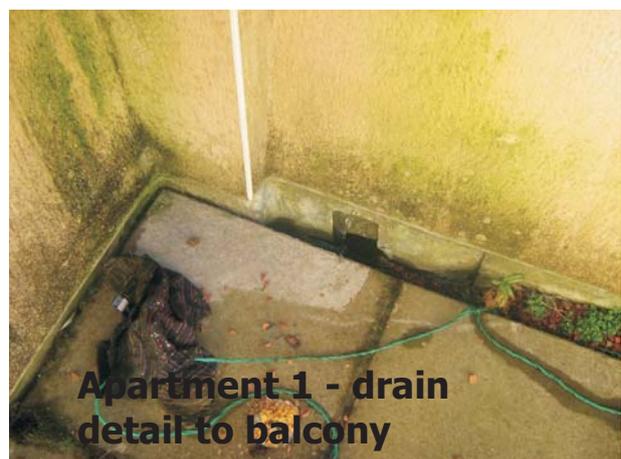
We would have concerns relating to the positioning of the flashing detail relevant to the finished floor level of the balcony, as it appears very close to the ground.

In the event of a prolonged spell of rain, and in combination with the previously mentioned factors (no fall to roof/clogged drains) could lead to excessive water being retained on the balcony and allowing it to climb up and over the flashing detail by capillary action thereby breaching the roofing membrane and allowing it into the walls and ceilings adjacent to the balconies.
